Damage quantification of built stone on Dark Gate (Belgrade, Serbia): sample of damage index application for decay rate evaluation

Maja Franković, Nevenka Novaković, Vesna Matović

Received: 16 May 2014 / Accepted: 31 October 2014 / Published online: 4 December 2014
© Springer-Verlag Berlin Heidelberg 2014

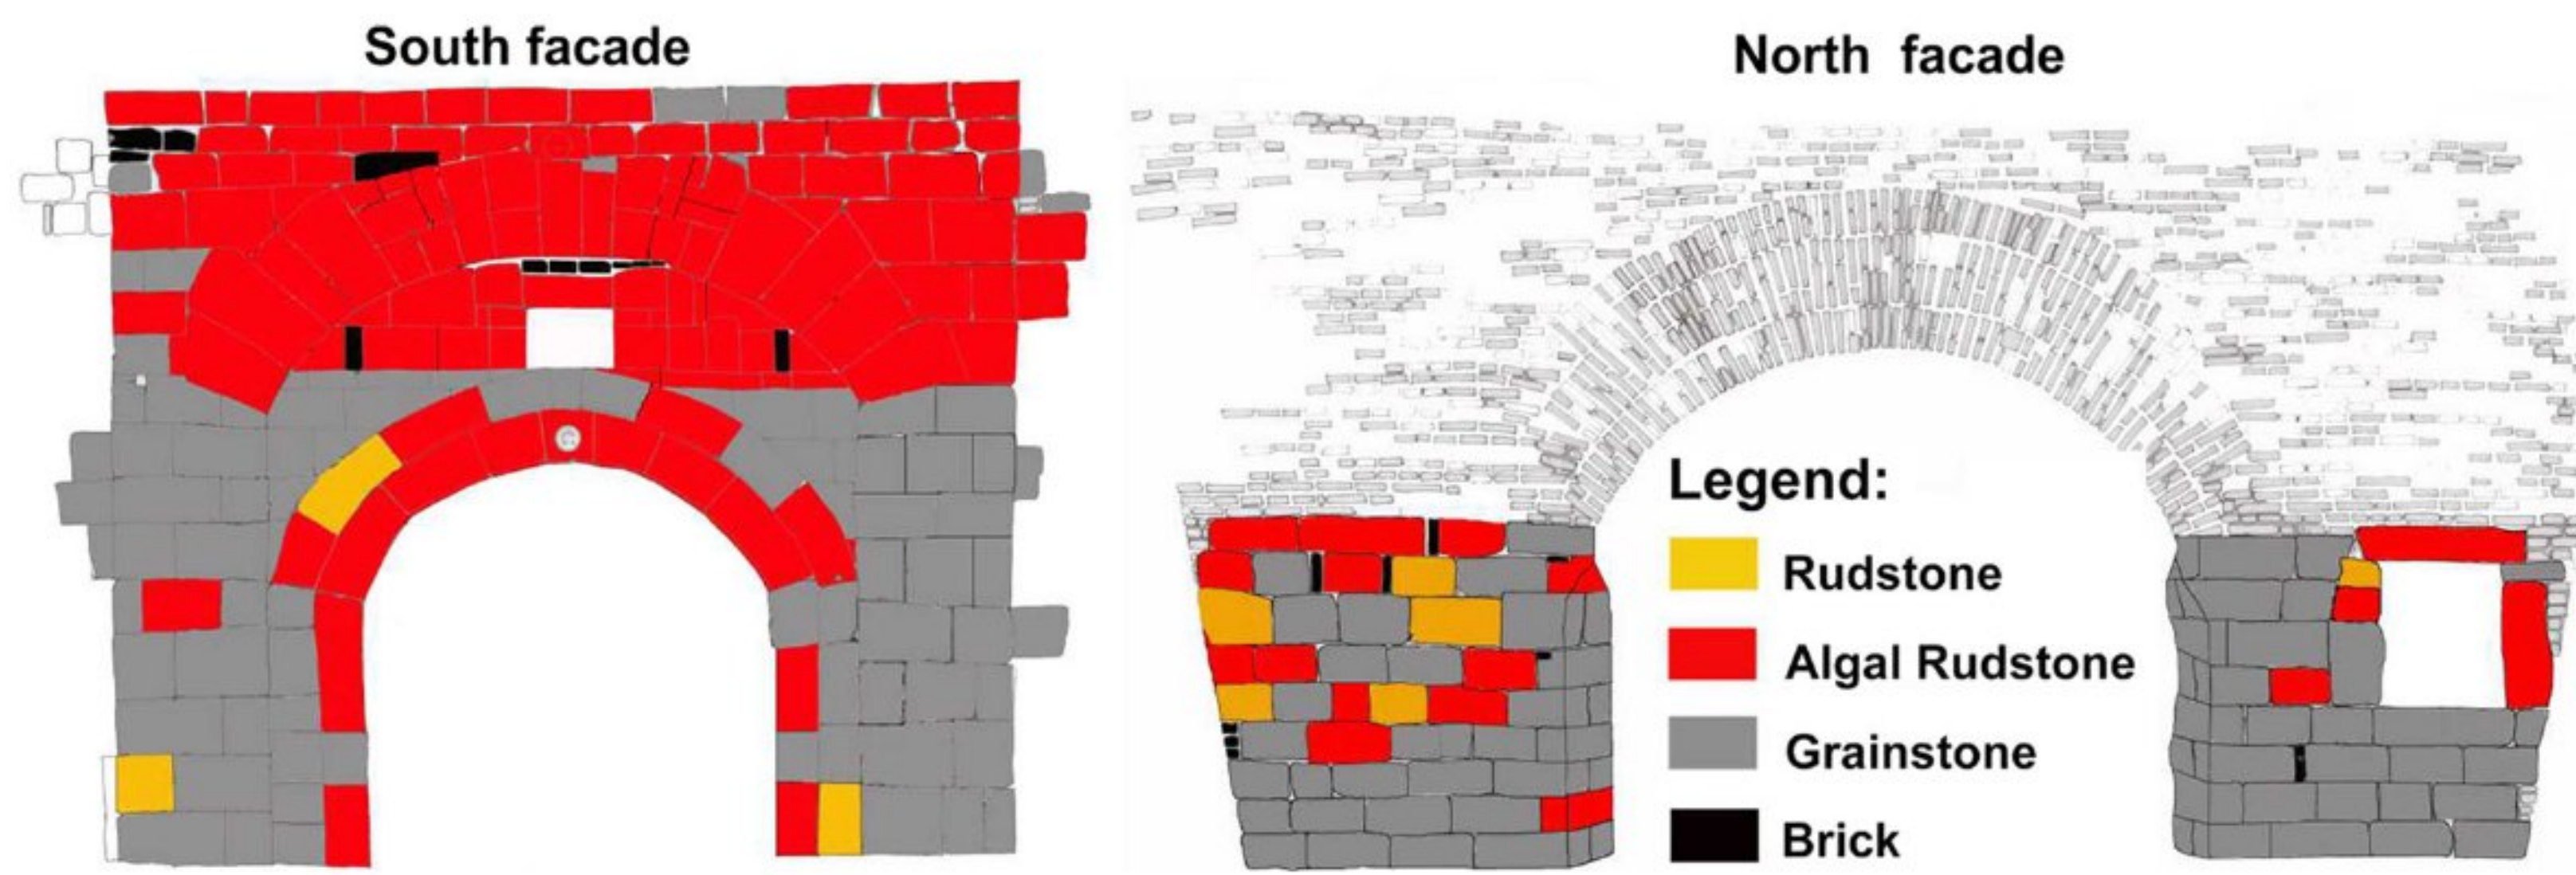
Fig. 3 The results of the lithological mapping of rock types for south and north façades of the Dark Gate

The results of lithological mapping of north and south façades of Dark Gate are documented on Fig. 3a, b. The grainstone microfacies (biosparite) dominates in the lower part south façades, while the algal rudstone are built in the upper part and arch. For the most part of north façade, grainstone microfacies was used, although algal rudstone identified rarely. Rudstone microfacies occur only sporadically, probably used during the latter restoration phases. In addition, brick was also used to fill some gaps and for filling the empty spaces between limestone blocks or gaps caused by completely destroyed blocks.

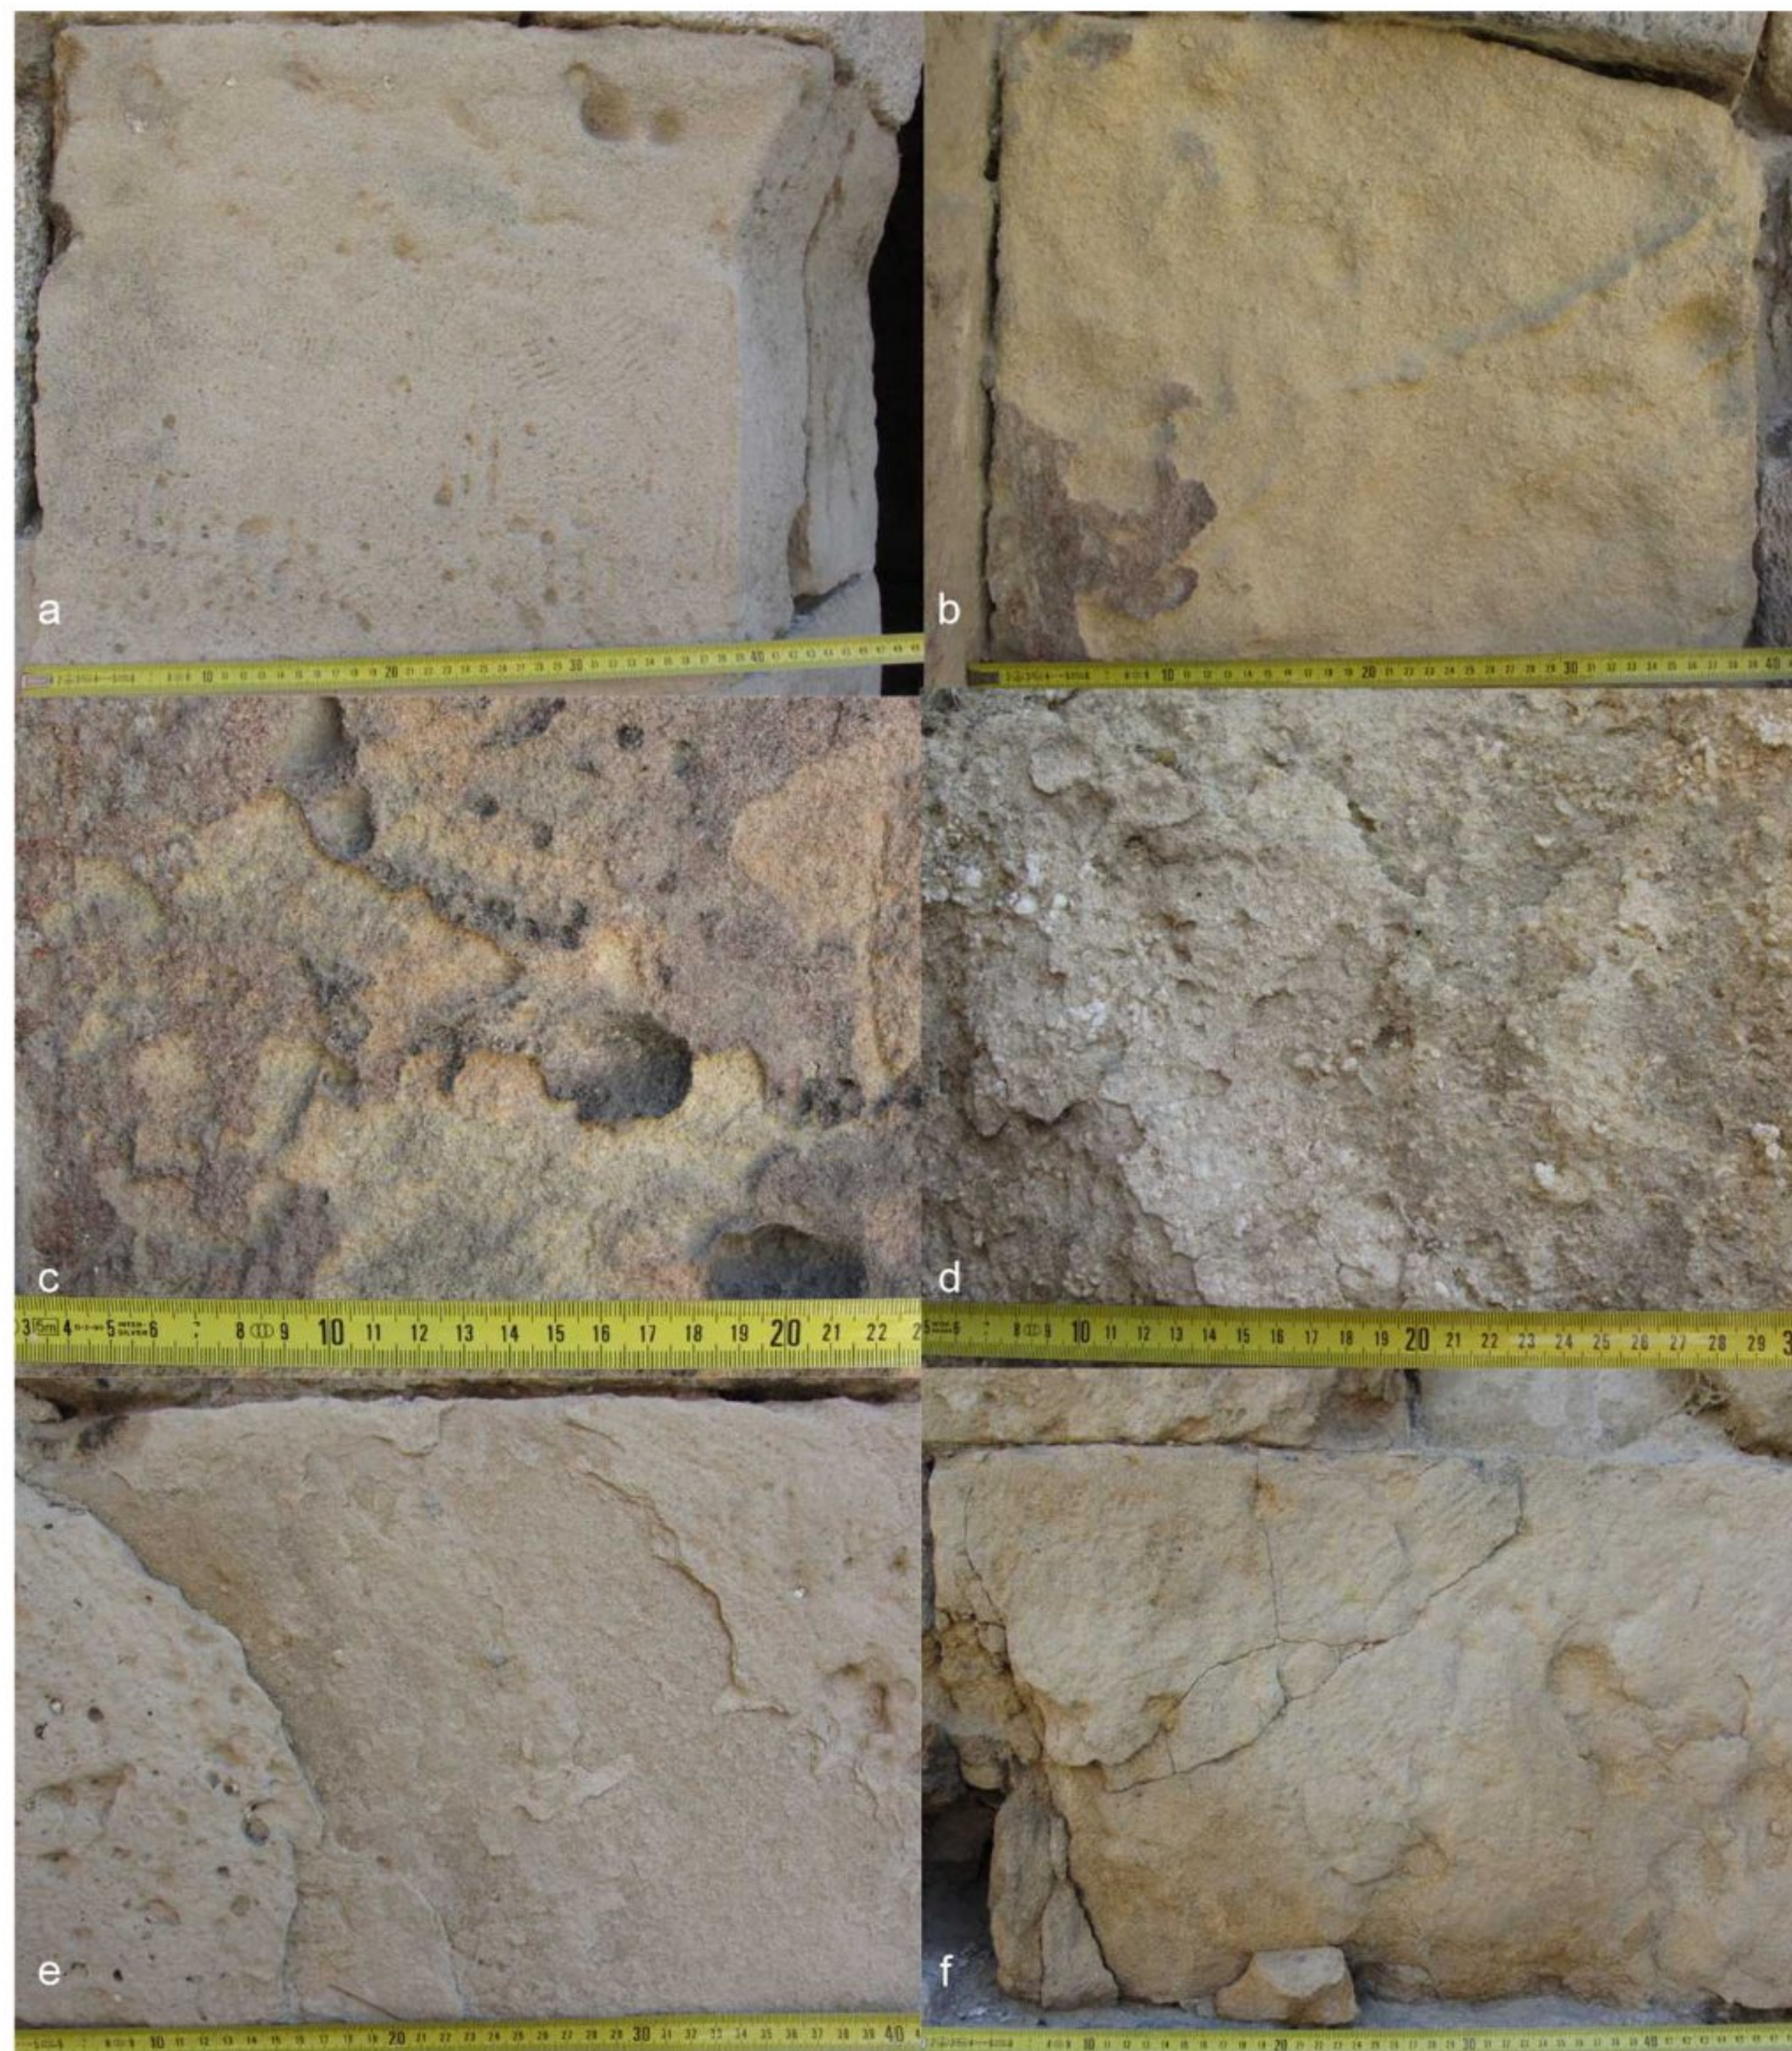
Mapping of Dark Gate’s façades and registration of weathering forms for each built stone block individually enabled characterization of stone degradation according to the type and intensity. It showed that all five groups of damage categories are present on built stone blocks i.e., category “no visible damage” was not observed. As far as groups of weathering forms are concerned, most dominant are loss of stone material, deposits in the form of crusts and detachment (Fig. 4). Loss of stone material is generally presented as surface recession and relief, only occasionally as outburst. Black crusts and white calcite crusts are present on majority of the stone blocks on the south façade. While black crusts are the ones that provoke surface recession, white crusts are thin and uniformly cover the surface of stone blocks. Discoloration is present as chromatic color change due to the oxidation

of Fe-components and due to accumulation of coloring components near the stone surface. This form of degradation was identified in a number of calcarenite blocks on the south façade. Soiling occurs in the form of deposition of weakly bound atmospheric particles of dust, soot, soil, or sludge and is present on the blocks in the lower zones of façades. Biological colonization in the form of microorganisms is present on the ground level where moisture is retained. Detachment is presented in the forms of granular disintegration, contour scaling, and detachment of crusts with stone material. Fissures do not present important feature as they are present only on several individual stone blocks.

Fig. 4 Weathering forms on the Dark Gate: **a** relief, **b** surface recession and granular disintegration, **c** remains of black crust, discoloration and detachment of crusts with stone material, **d** Surface

recession, flaking and granular disintegration, remains of white crust, **e** contour scaling and flaking, **f** outburst and fissures

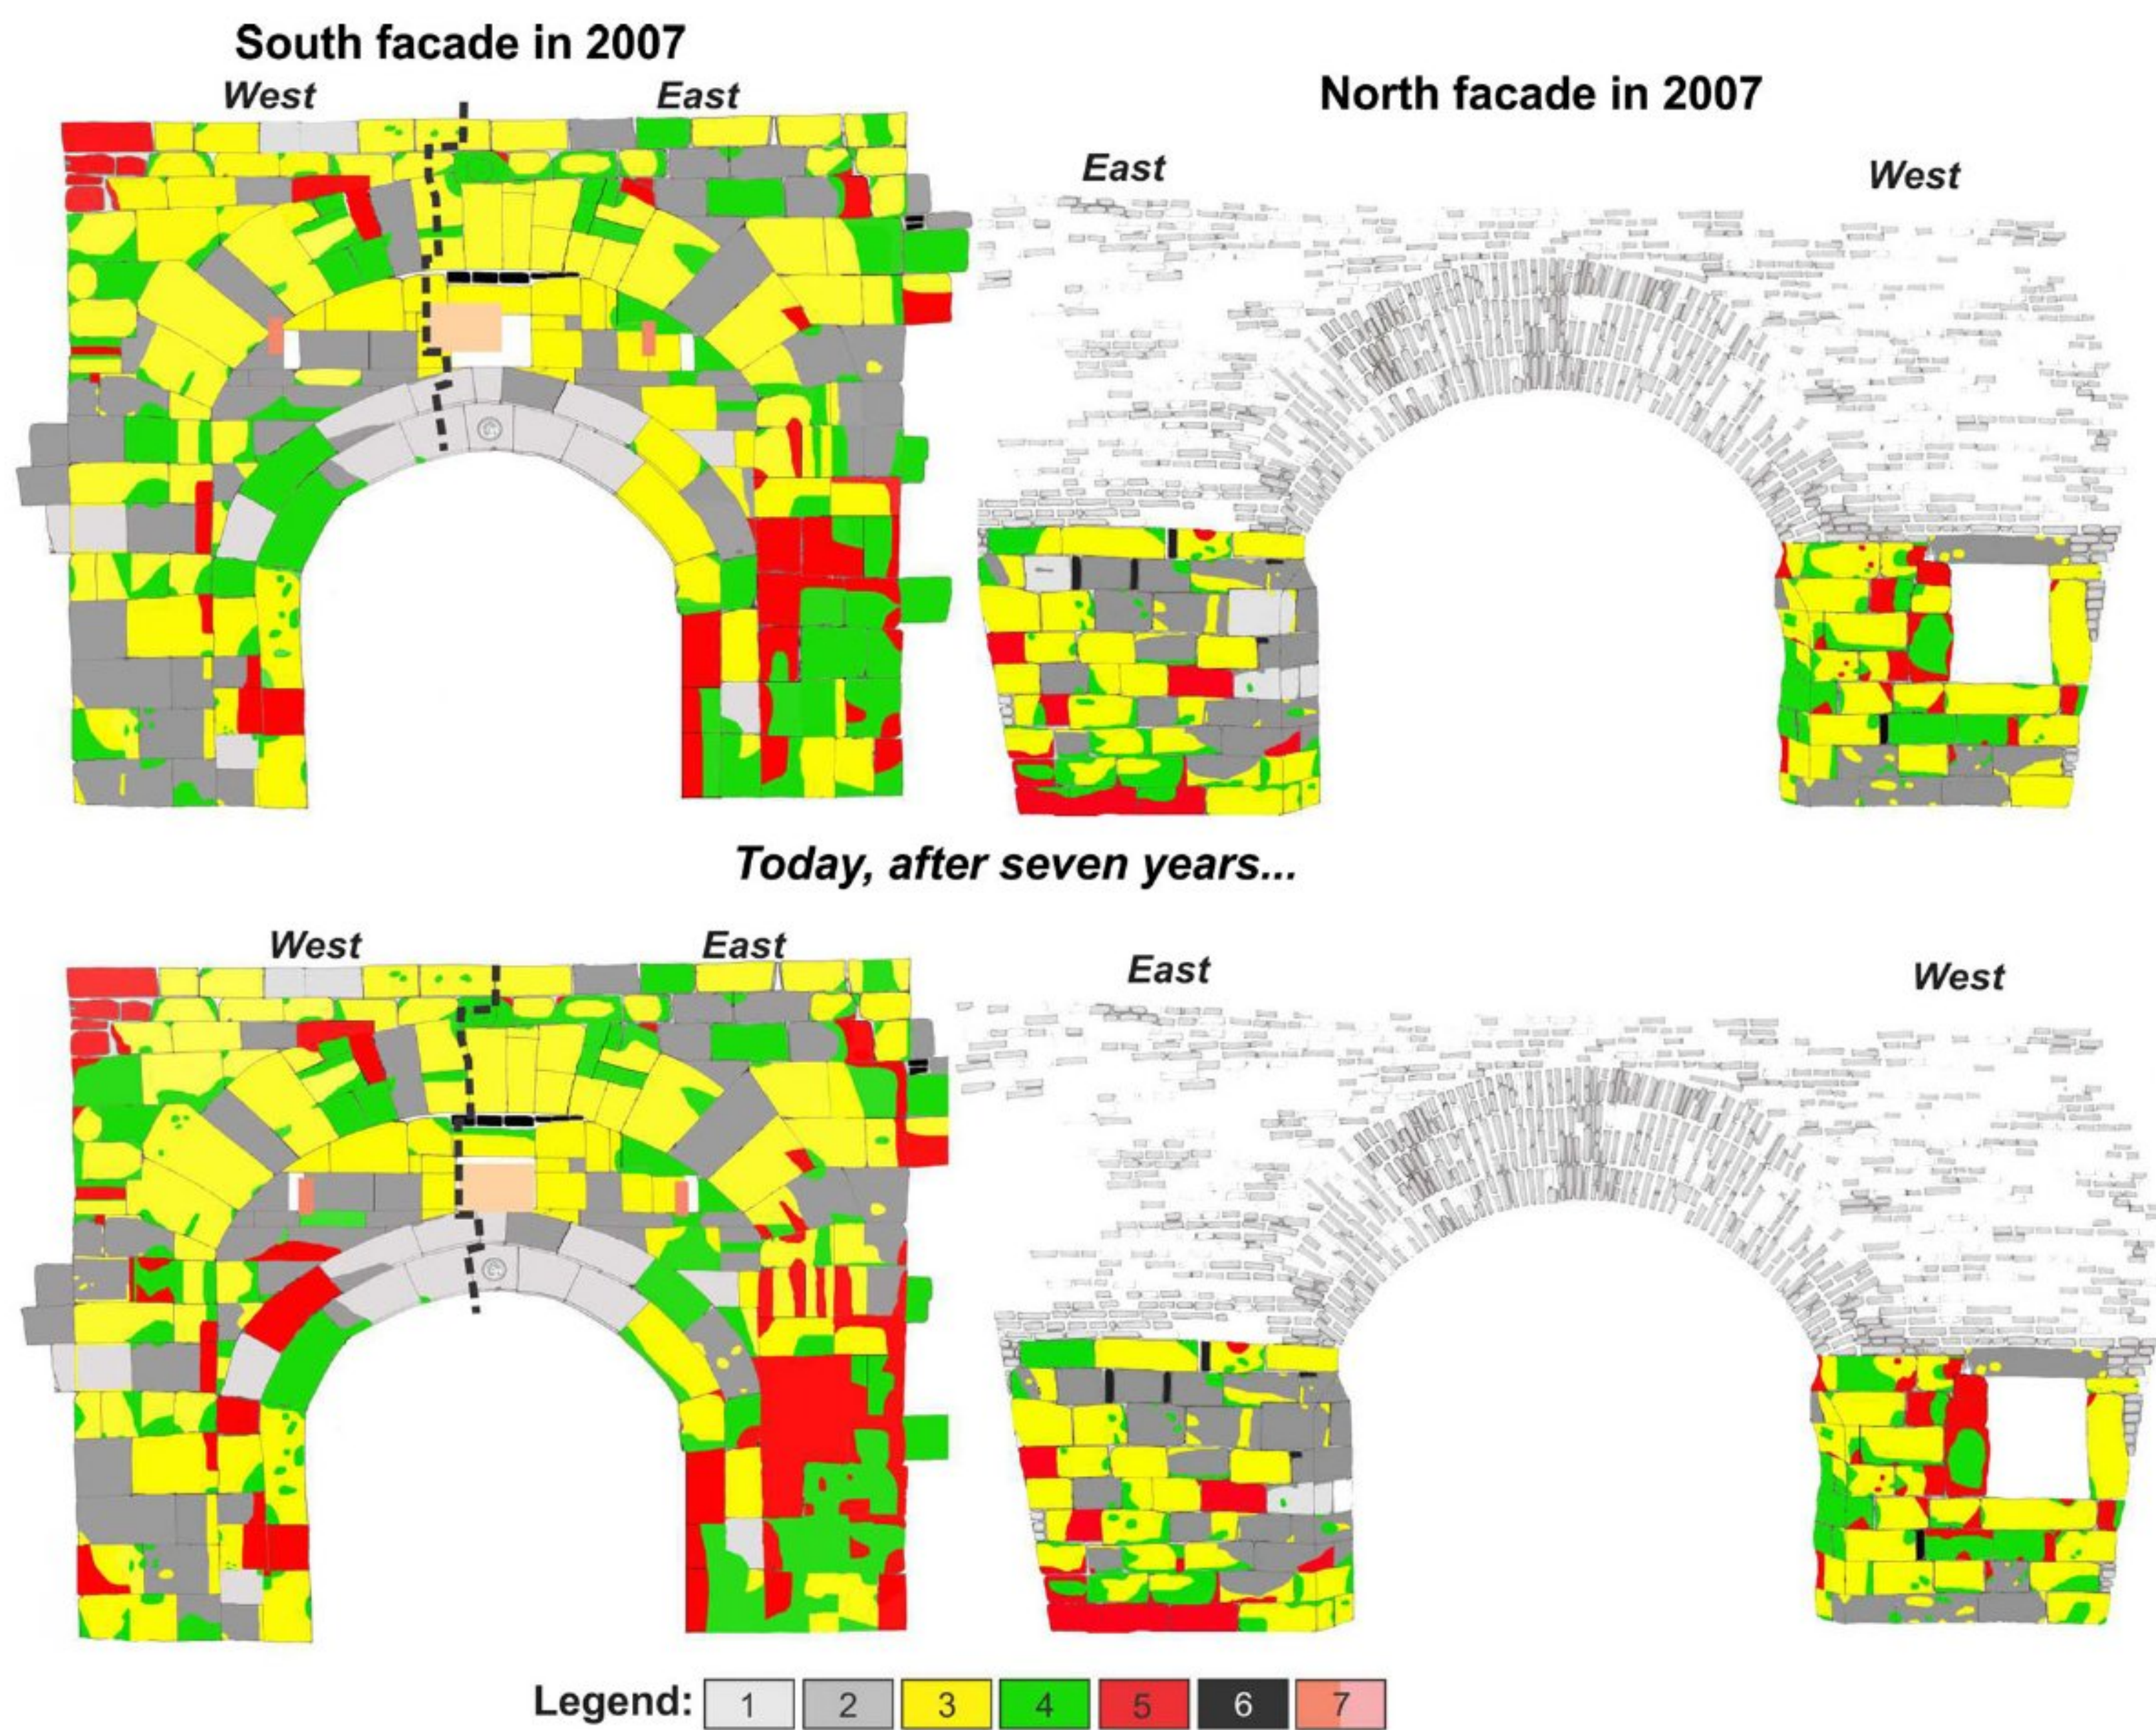
Results of the weathering forms mapping during 2007 showed that very heavy and heavy damage were present on 28 % of the Dark Gate’s stone surface (9 % very heavy, 19 % heavy; Table 2). The largest part, 43 % of stone surface, was moderately damaged, while 29 % showed slight and very slight damage (22 % slight, 7 % very slight) (Fig. 5–2007 mapping and Table 2).

In 2014, the level of damage changed slightly. Very heavy and heavy damage are now present on 30 % of the stone surface (very heavy 12 %, heavy damage 18 %). Moderate damage affects 42 % of the stone surface, while slight and very slight damage affects 28 % (slight 21 %, very slight damage remained unchanged 7 %) (Fig. 5–2014 mapping). From looking at the south and north

Fig. 5 Mapping of damage category on the Dark Gate; 1 very slight damage; 2 slight damage; 3 moderate damage; 4 severe damage; 5 very severe damage; 6 bricks; 7 open gaps or mortar surface

2007 and in 2014 this number dropped to 1 % (Table 2). When damage categories are considered by dividing façades vertically to the east and west half, percentages of heavy and very heavy damage implicate that the east oriented half has suffered more damage than the west half (32 % in 2007 going to 34 % in 2014 for the east half, 22 % going to 27 % for the west half) (Table 2).

Correlations among intensity of weathering forms and damage category in relation to orientation of gate parts reveal very interesting data. Looking at the façades oriented to south and north and their results of mapping damage category, no significant difference can be noted. The distribution of damage category is almost random on both façades. What is obvious from looking at the weathering maps, as well as at damage category, is that the half of the gate oriented to the east is more damaged than the half oriented to the west (Fig. 5 and Table 3).

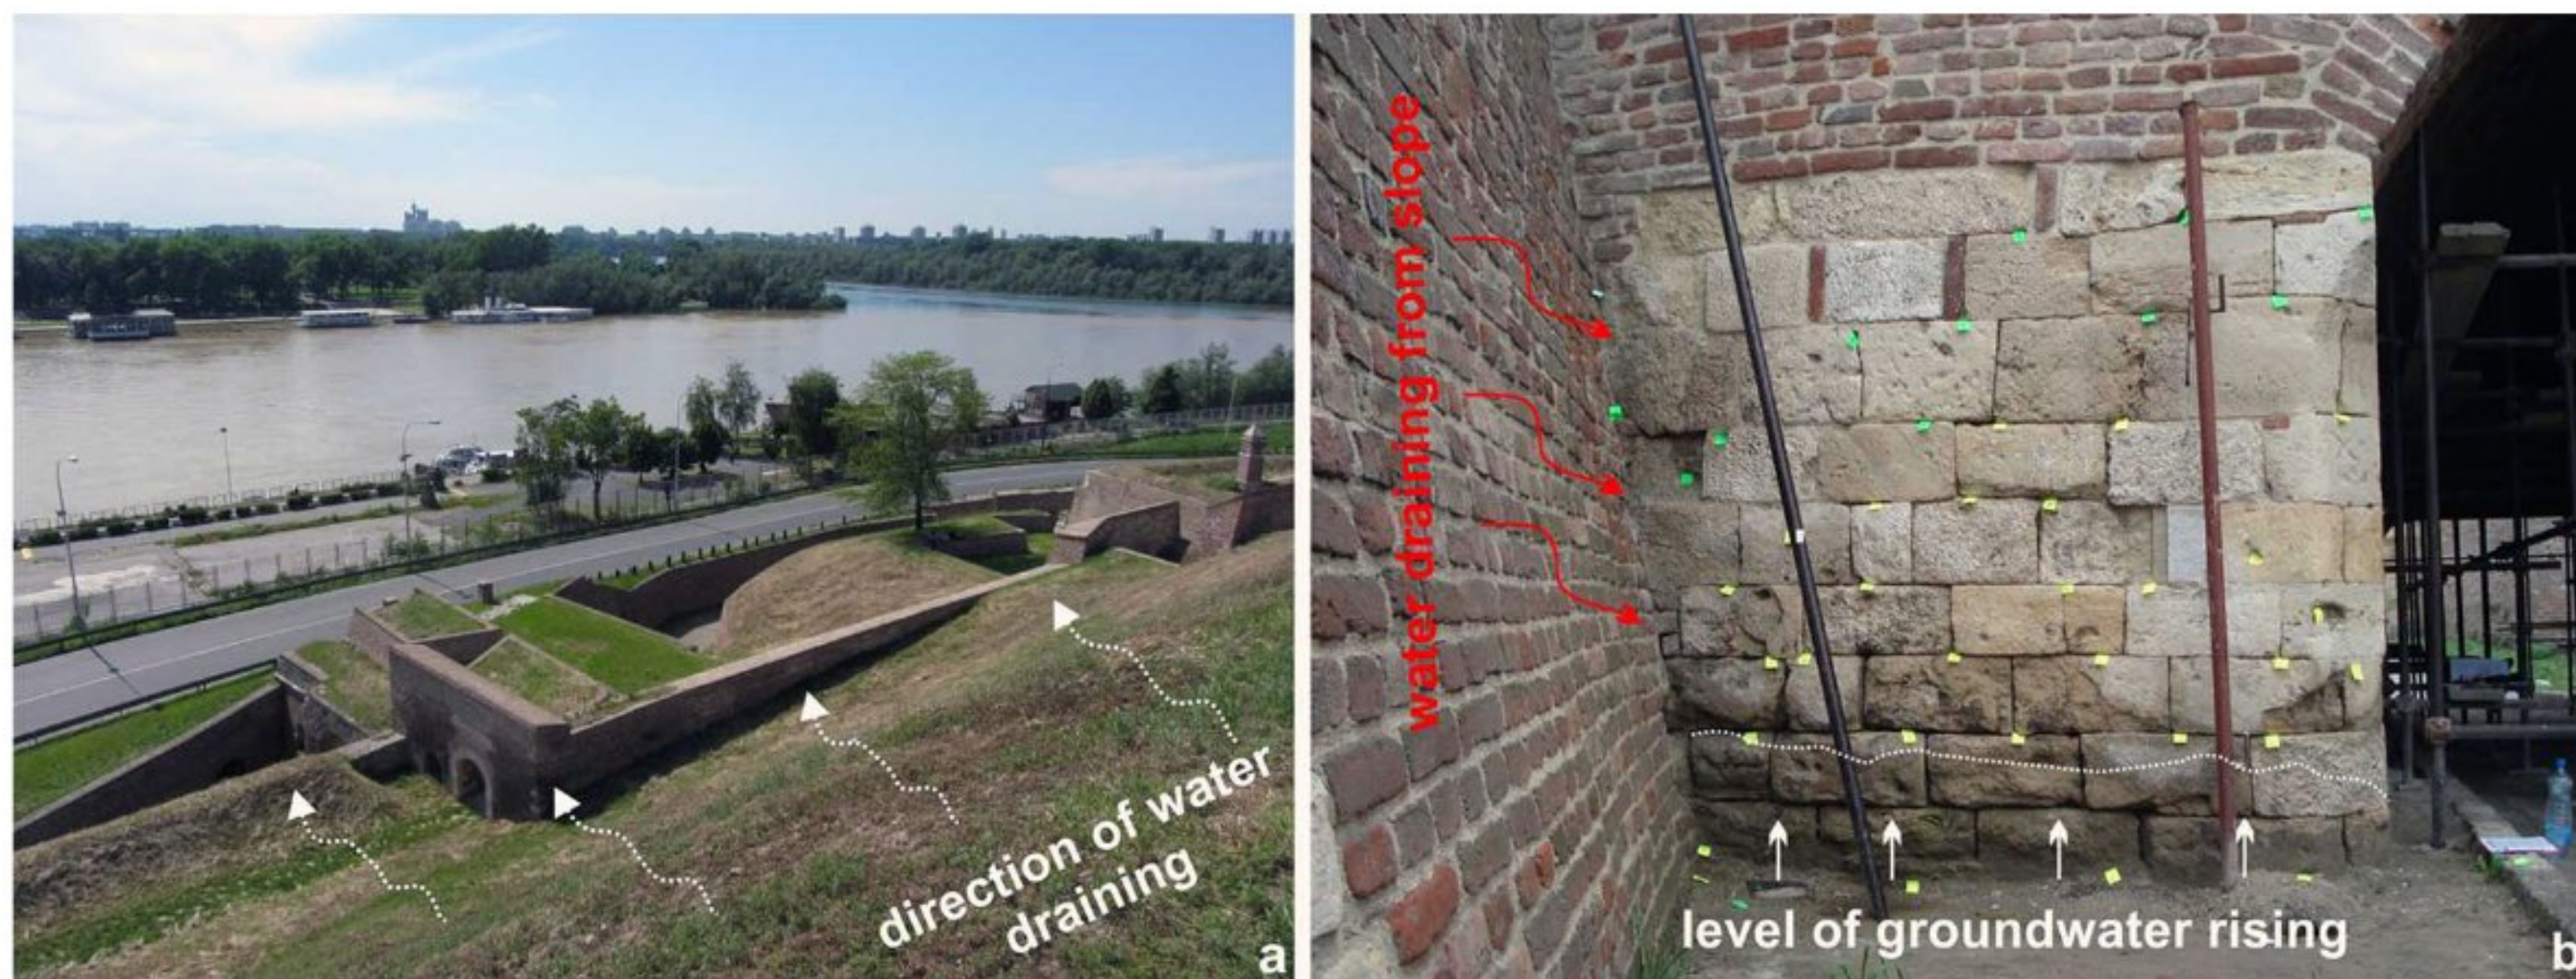
This could be explained by the gate position inside of the fortification; the gate is leaning on the slope which descends from the Upper Town of the fortress. This slope is permanent source of moisture/water for eastern side of gate. Water draining from the slope causes higher moisture content in the walls on the eastern side of the gate in comparison to the western side (Fig. 7a). It has already been mentioned that these built limestones have high porosity which enables water to penetrate into the inner parts of blocks. Pore communications and their size enable water circulation through all gate construction not only from slope, but also groundwater and rain water, too (Fig. 7b). Percolating rain water in sheltered stone blocks is related to the destroyed waterproofing layers above the gate. Although the upper part of the gate is more influenced by wind that results in the faster drying process, the lower part of façades is influenced by the groundwater rising up. Additionally, gate position close to the Sava river (only 50 m away) also contributes to the higher moisture influence on stone surface and rising velocity of decay processes. All of these sources of moisture/water caused dissolution of poorly cemented algal rudstone and sparite cement of grainstone. It resulted in crumbling, granular disintegration, or occurring of thin white crust on stone surface as consequence of redeposited dissolved calcite. Over prolonged periods, repeating of cycles of dissolve, wetting–drying and freeze–thaw caused continual increasing intensities of decay and very heavy damage in different forms of loss of stone materials (surface recession, relief, and outburst).

Fig. 7 a The position of Dark Gate and the direction of water draining from slope; b directions of water moving down slope and rising from the ground

quantifiable evidence that the eastern side is more damaged due to its position and contact with the slope (Fig. 7b).

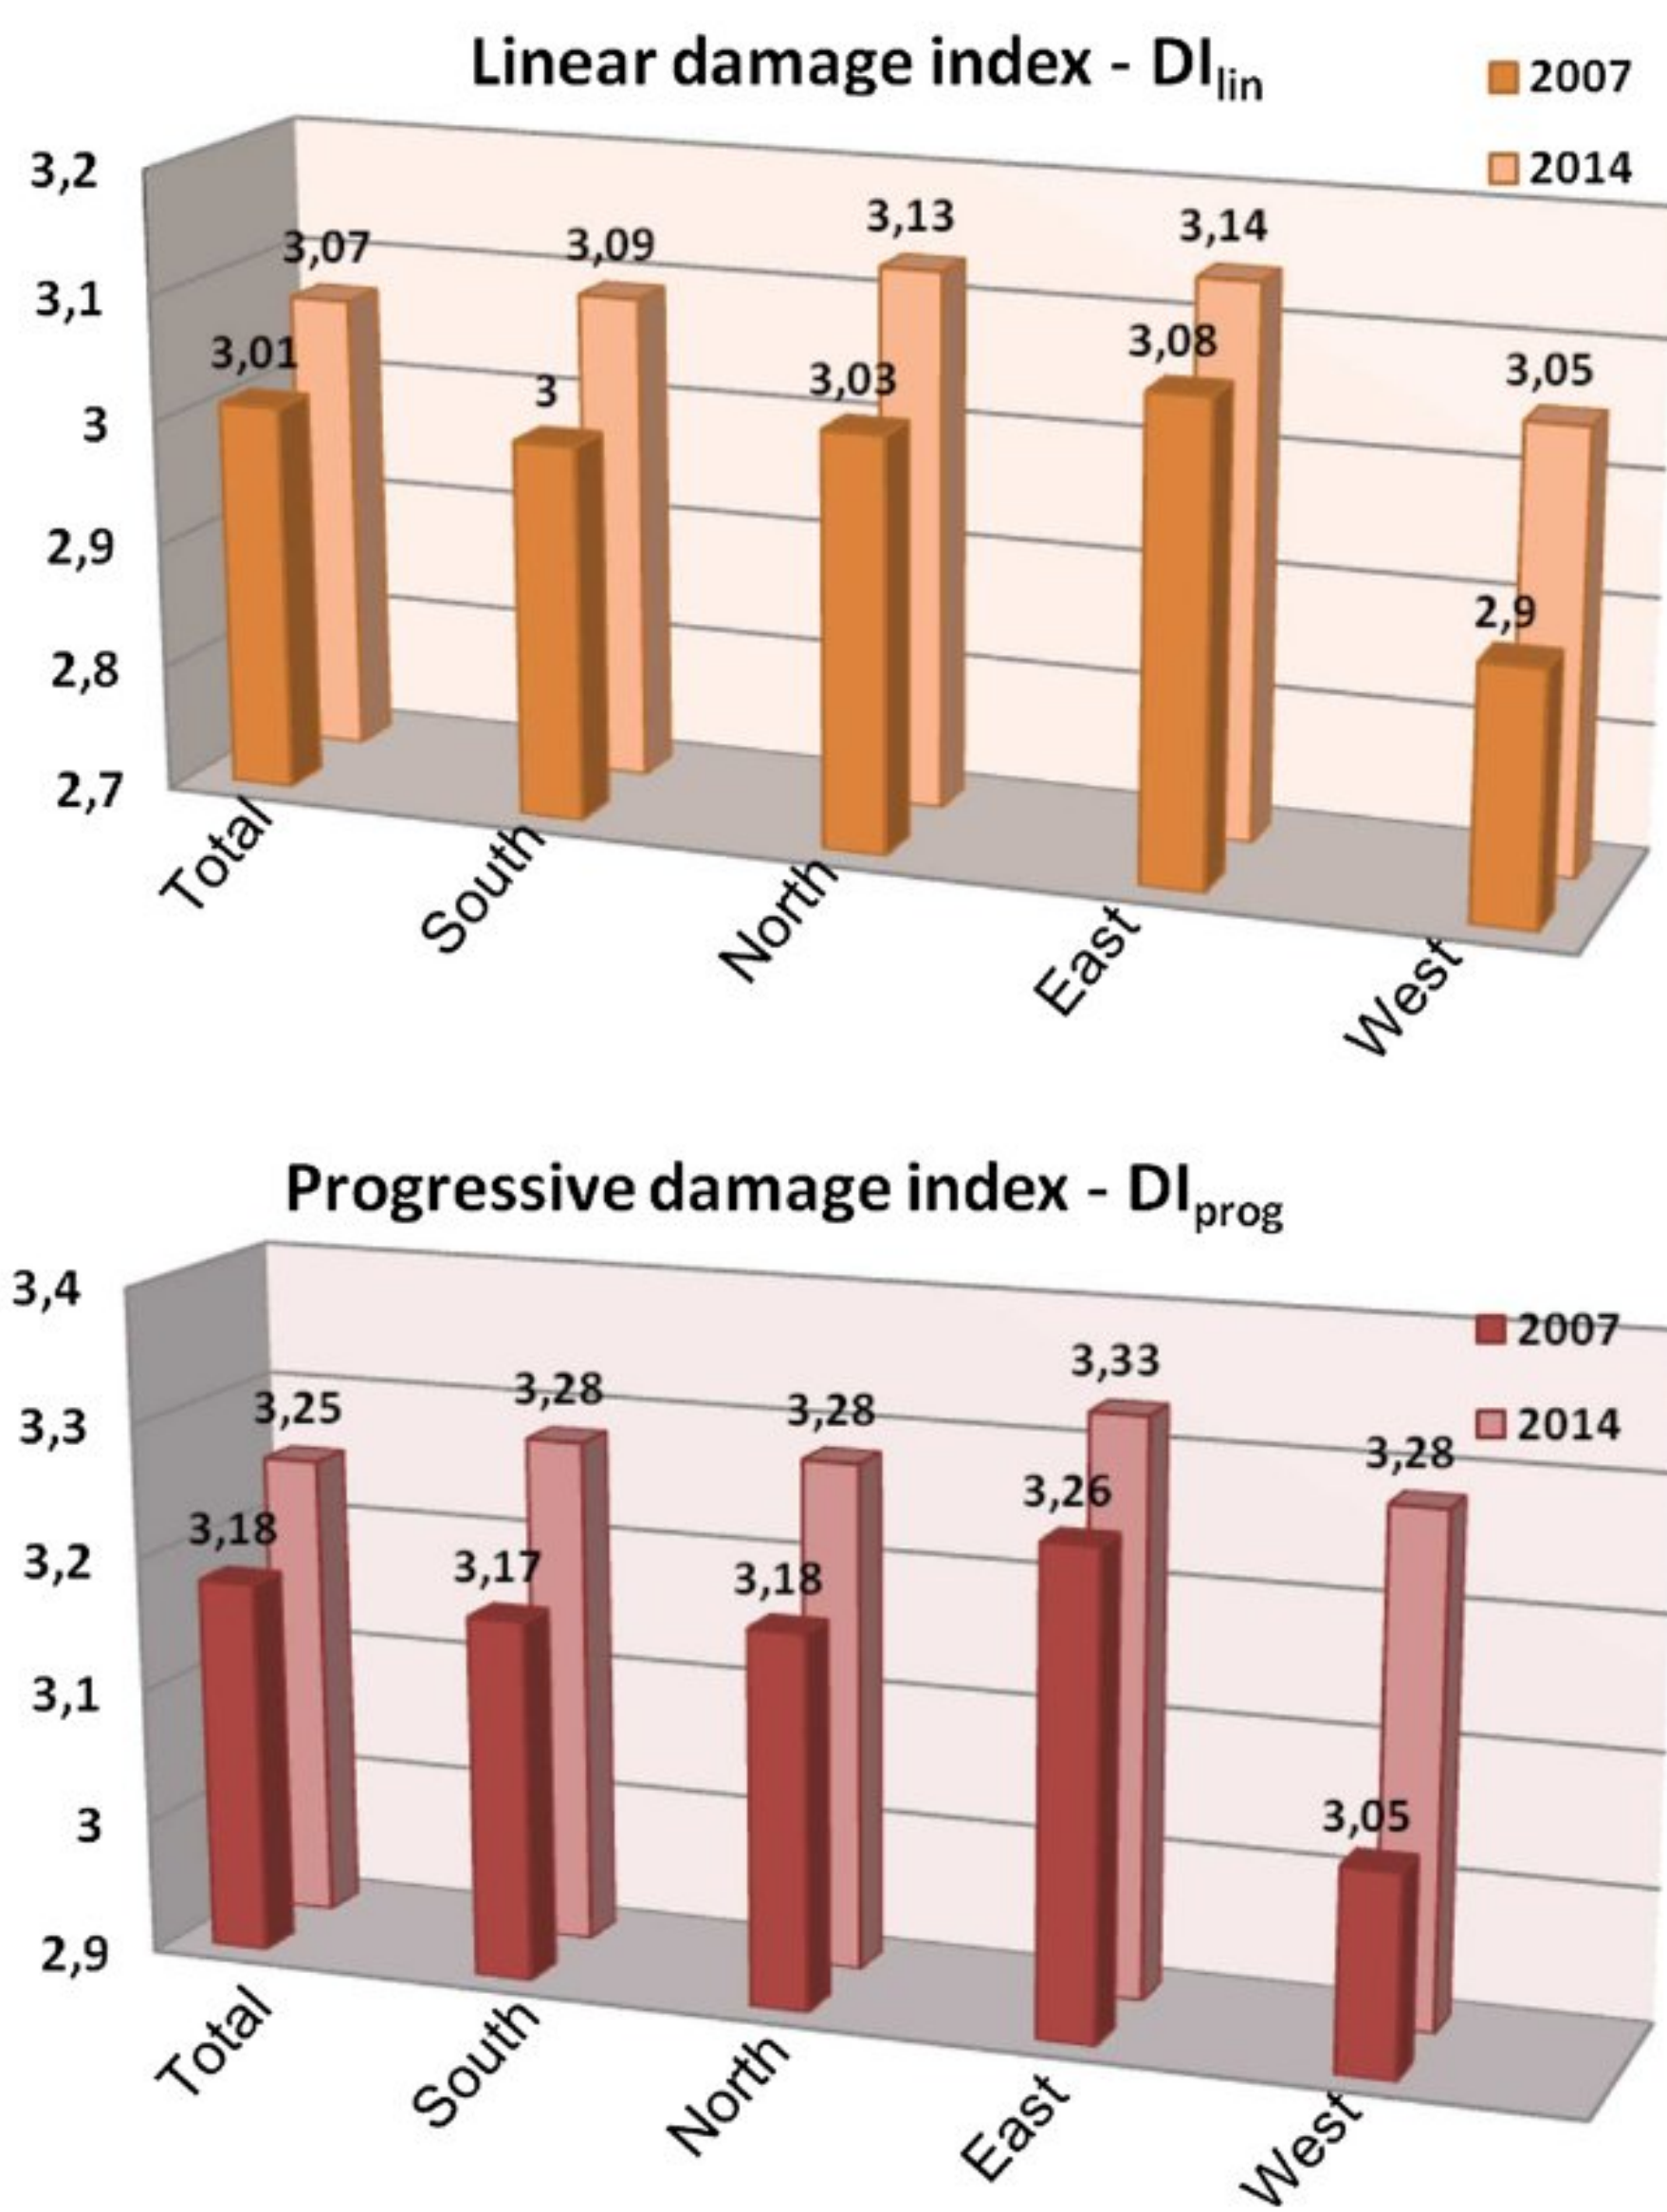
Fig. 8 Comparison of the calculated damage indices values

Fig. 8a, b, their values are in relation to gate’s orientation, too. The values of linear damage indices display insignificant differences between 2007 and 2014 for the entire gate as well as north and south façades. Nevertheless, the difference of linear damage indexes from 2007 to 2014 is significantly higher on the eastern part of the gate in comparison to western one (Fig. 8a). It is additional,

Generally, comparing progressive damage indices for 2007 and 2014, high rate of damage progression is evident—progressive damage index for the whole gate increased by 0.07 in only 7 years (Fig. 8b). Among north and south façade, there is no difference in values of damage progression, but this progression is significantly higher on the western side of the gate (0.23; see Table 3) than to eastern side (0.07).

This difference can be explained by chosen intensity class of weathering forms and its correlation to damage category. On the western half of the façade, the percentage of slight damage decreased by 5 %, from 2007 to 2014, while at the same time percentage of very heavy damage increased by the same 5 %. On the other hand, progressive damage index on the west side is coming close to the one on the east side (Table 3). This seemingly illogical inconsistency lies in the classification scheme of weathering forms (Table 1), i.e., in the intensities related to damage categories. According to chosen classification scheme in our study, loss of material higher than 5 cm in depth, or 1,000 cm³ in volume is considered as very heavy damage. Although the loss of material on some stone blocks was rated as very heavy damage in 2007, it is evidently progressing during the past 7 years (Fig. 9). However, this progression could not be noted on damage map for 2014, due to defined ranges of intensity—a class does not allow for this progression to register. It should be noted that classification scheme was developed in the frame of 2007 condition survey which had the objective to estimate the urgency for conservation and to help identify stone blocks in need of more extensive restoration work. Nevertheless, damage progression is evident and the ranking of the monument corresponds to the increasing need and urgency of preservation measures.

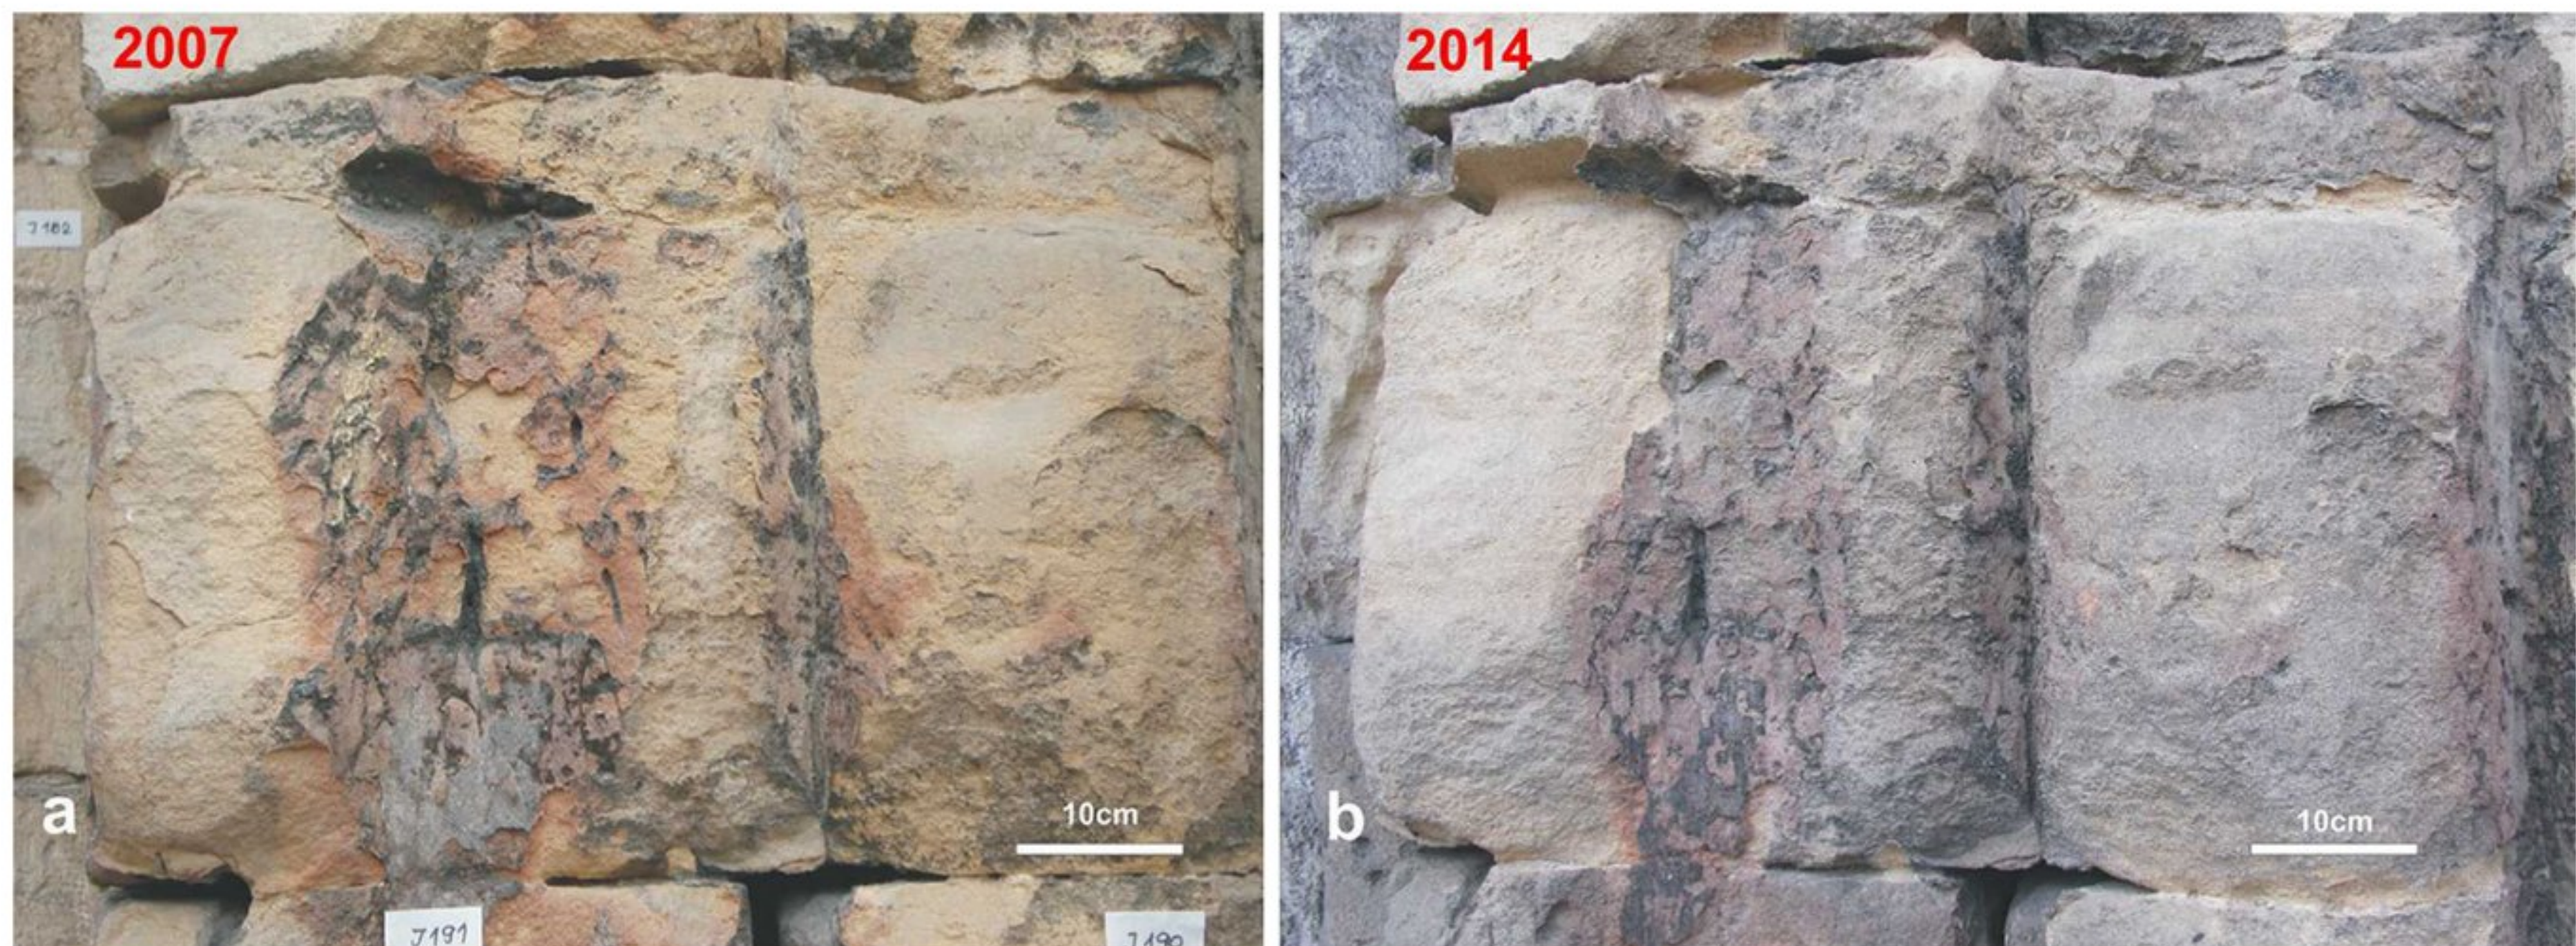
Fig. 9 Evident increase of stone decay on southern façade of the Dark Gate

Finally, high values of damage indices (>3) point out the need and urgency of intervention. Their application allows one to locate the zone and cause of decay, too. Damage categories mark those parts of Dark Gate where future interventions have to be applied. Significant differences of damage indices values from 2007 and 2014 show
