Review of the Failure at the Flotation Tailings Storage Facility of the “Stolice” Mine (Serbia)

Dragana Nišić *

Abstract: A detailed analysis of the accident that occurred at the flotation tailings storage facility (TSF) at the inactive mine “Stolice” in 2014 is provided in this paper. All factors that caused the accident have been analyzed, with a review of the consequences of the accident, their accident class according to the Global Industry Standard on Tailings (GISTM), and the implemented measures to rehabilitate the TSF and the surrounding area after the accident. It has been concluded that the TSF had not been properly maintained even before the accident occurred and that the unfavorable weather conditions in Serbia in the May of that year contributed to the filtration disturbance and multiple tailings spillages from the TSF. It has been stated that the consequences according to the GISTM span from “low” to “significant”, with the group of environmental consequences having the highest rank (3). Although the accident occurred without recorded human casualties, with the damage being of a local nature, it is considered one of the most significant accidents at a TSF in Serbia

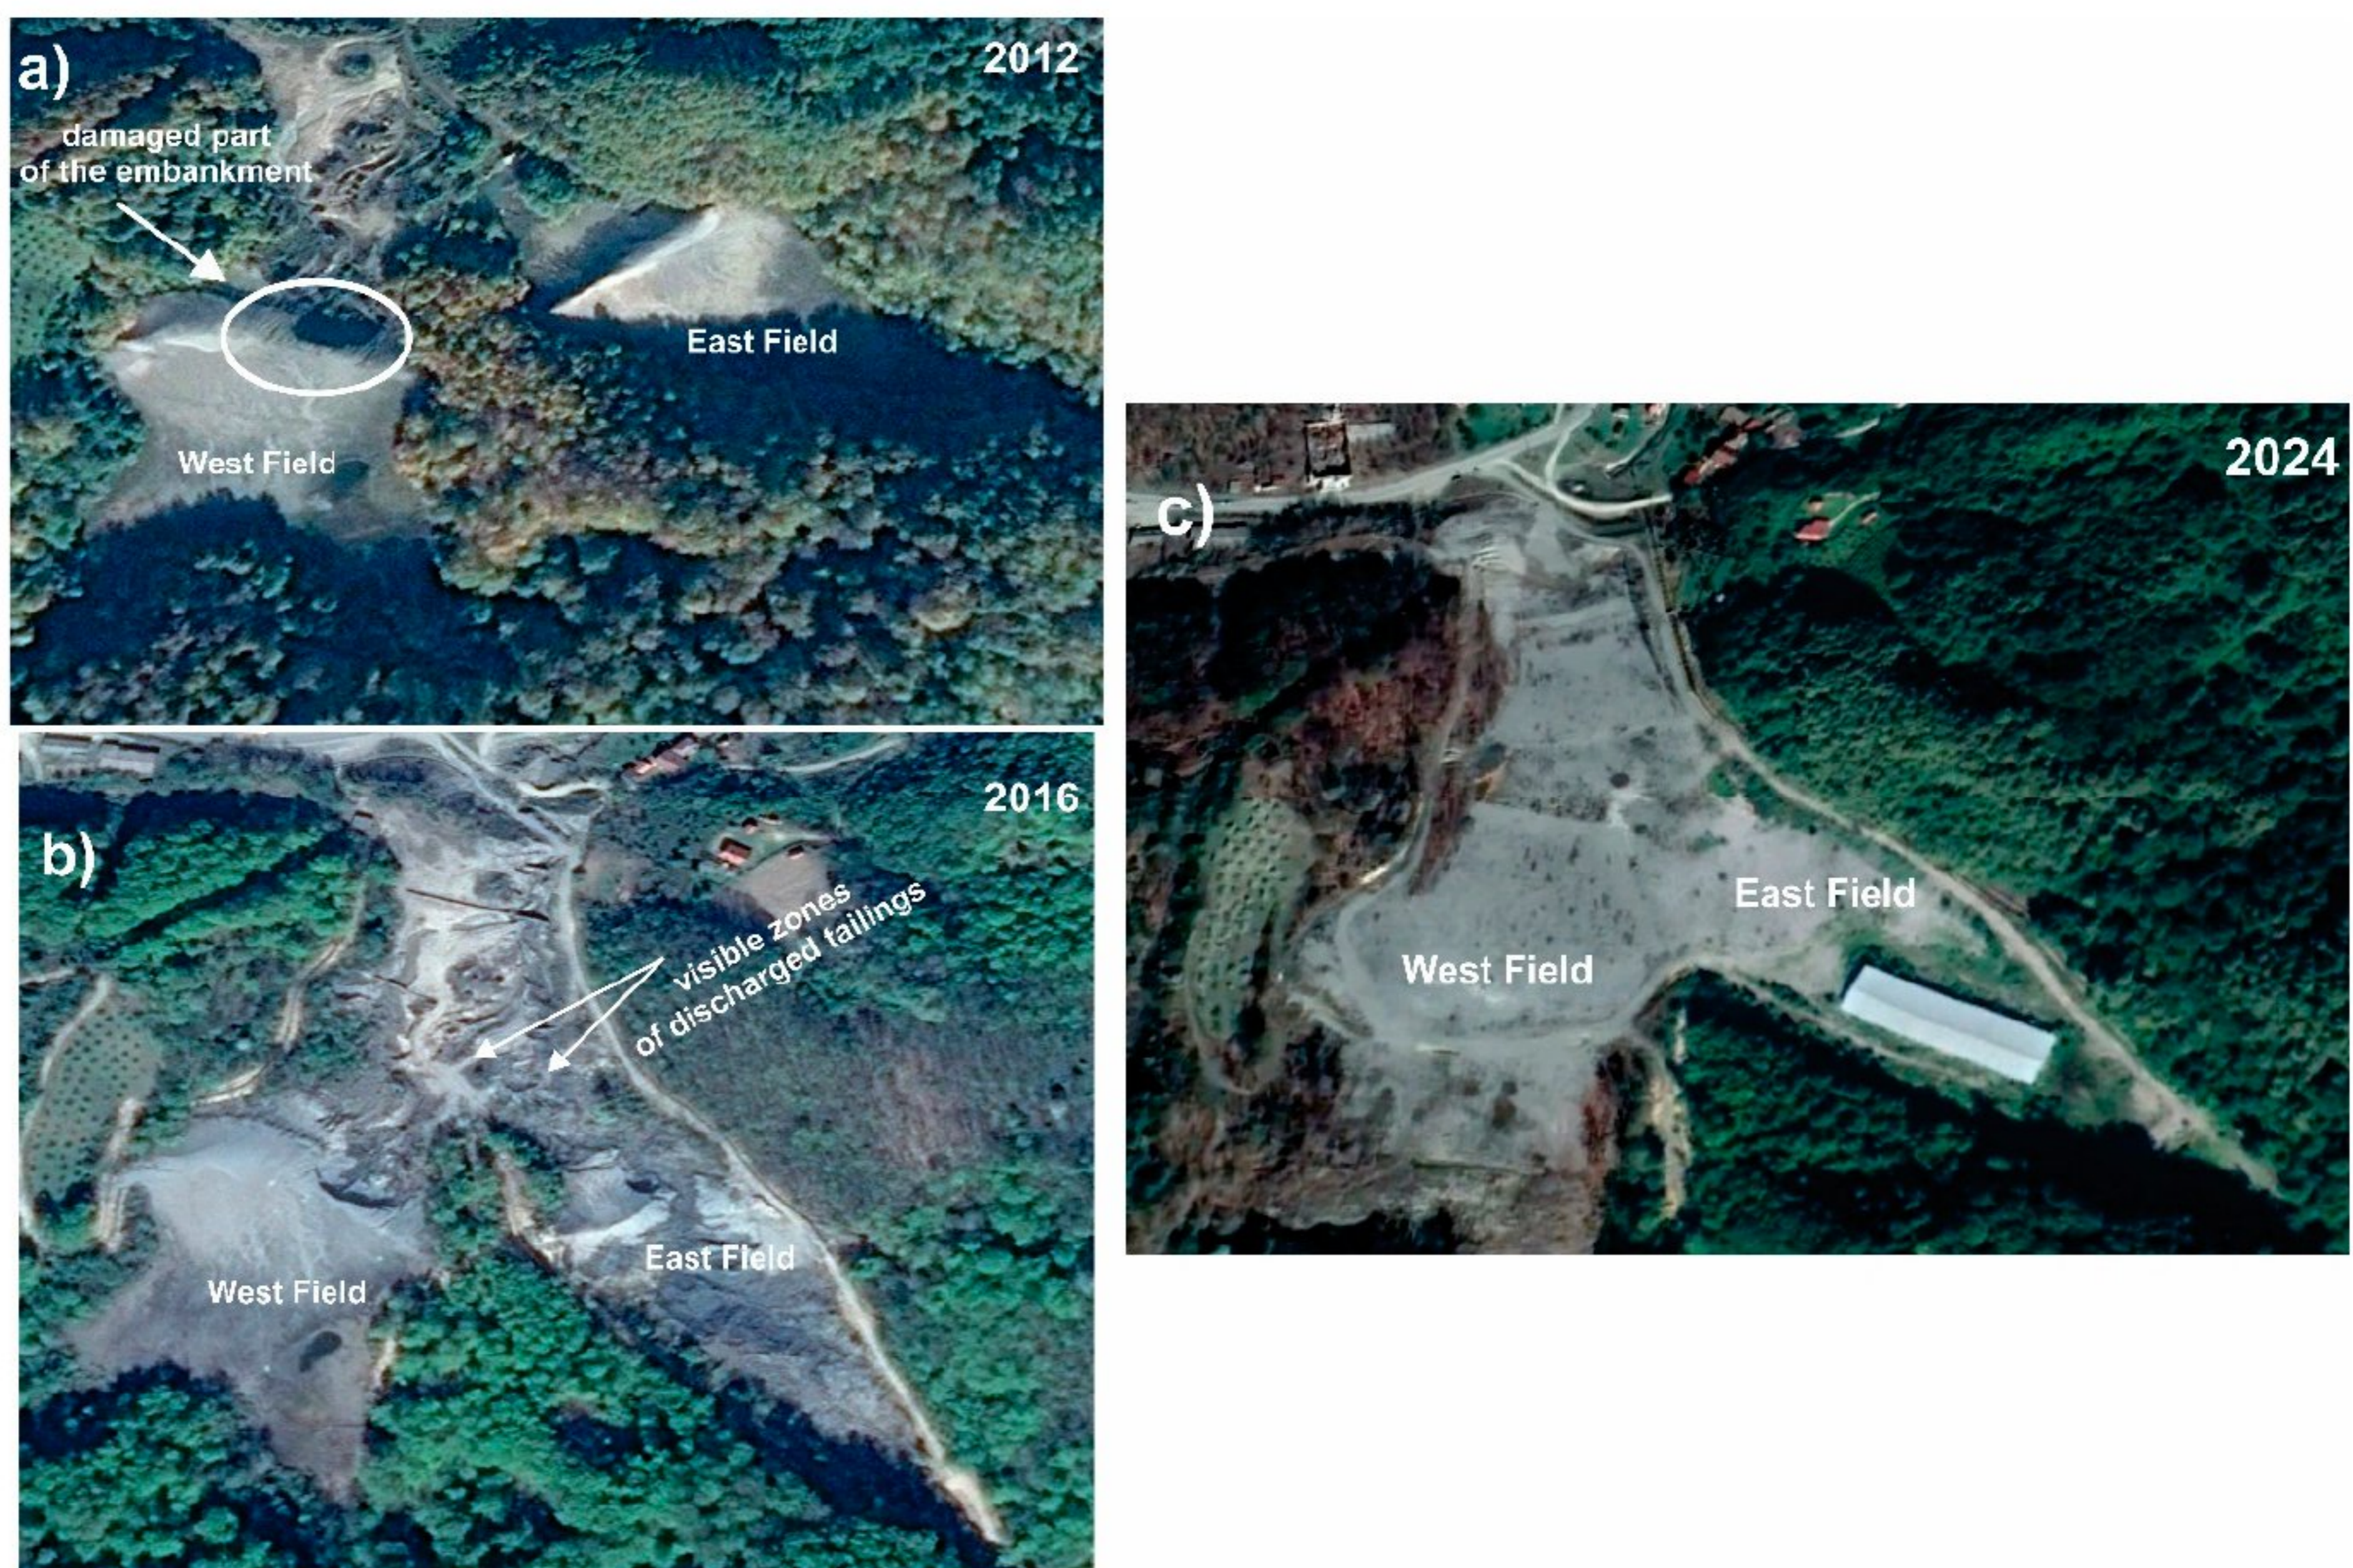
The flotation TSF of the “Stolice” mine has not been active since 1990. According to the image of the TSF from 2012 (Figure 3a), it is clear that the embankment on the west field of the TSF was already damaged. Regardless of this fact, no accidents had been recorded at this TSF before. During May of 2014, the so-called “Tamara” cyclone caused heavy rainfall and caused what are considered to be the largest floods ever recorded in certain parts of Central and West Serbia [15]. The region of the TSF of the mine “Stolice” had 200–250 mm of rainfall in only 3 days, surpassing the so-called 100-year flood [16].

Figure 3. The flotation TSF of the mine “Stolice”: (a) image from 2012, before the accident; (b) image from 2016, after the accident and before rehabilitation; (c) image from 2024, after rehabilitation [17].

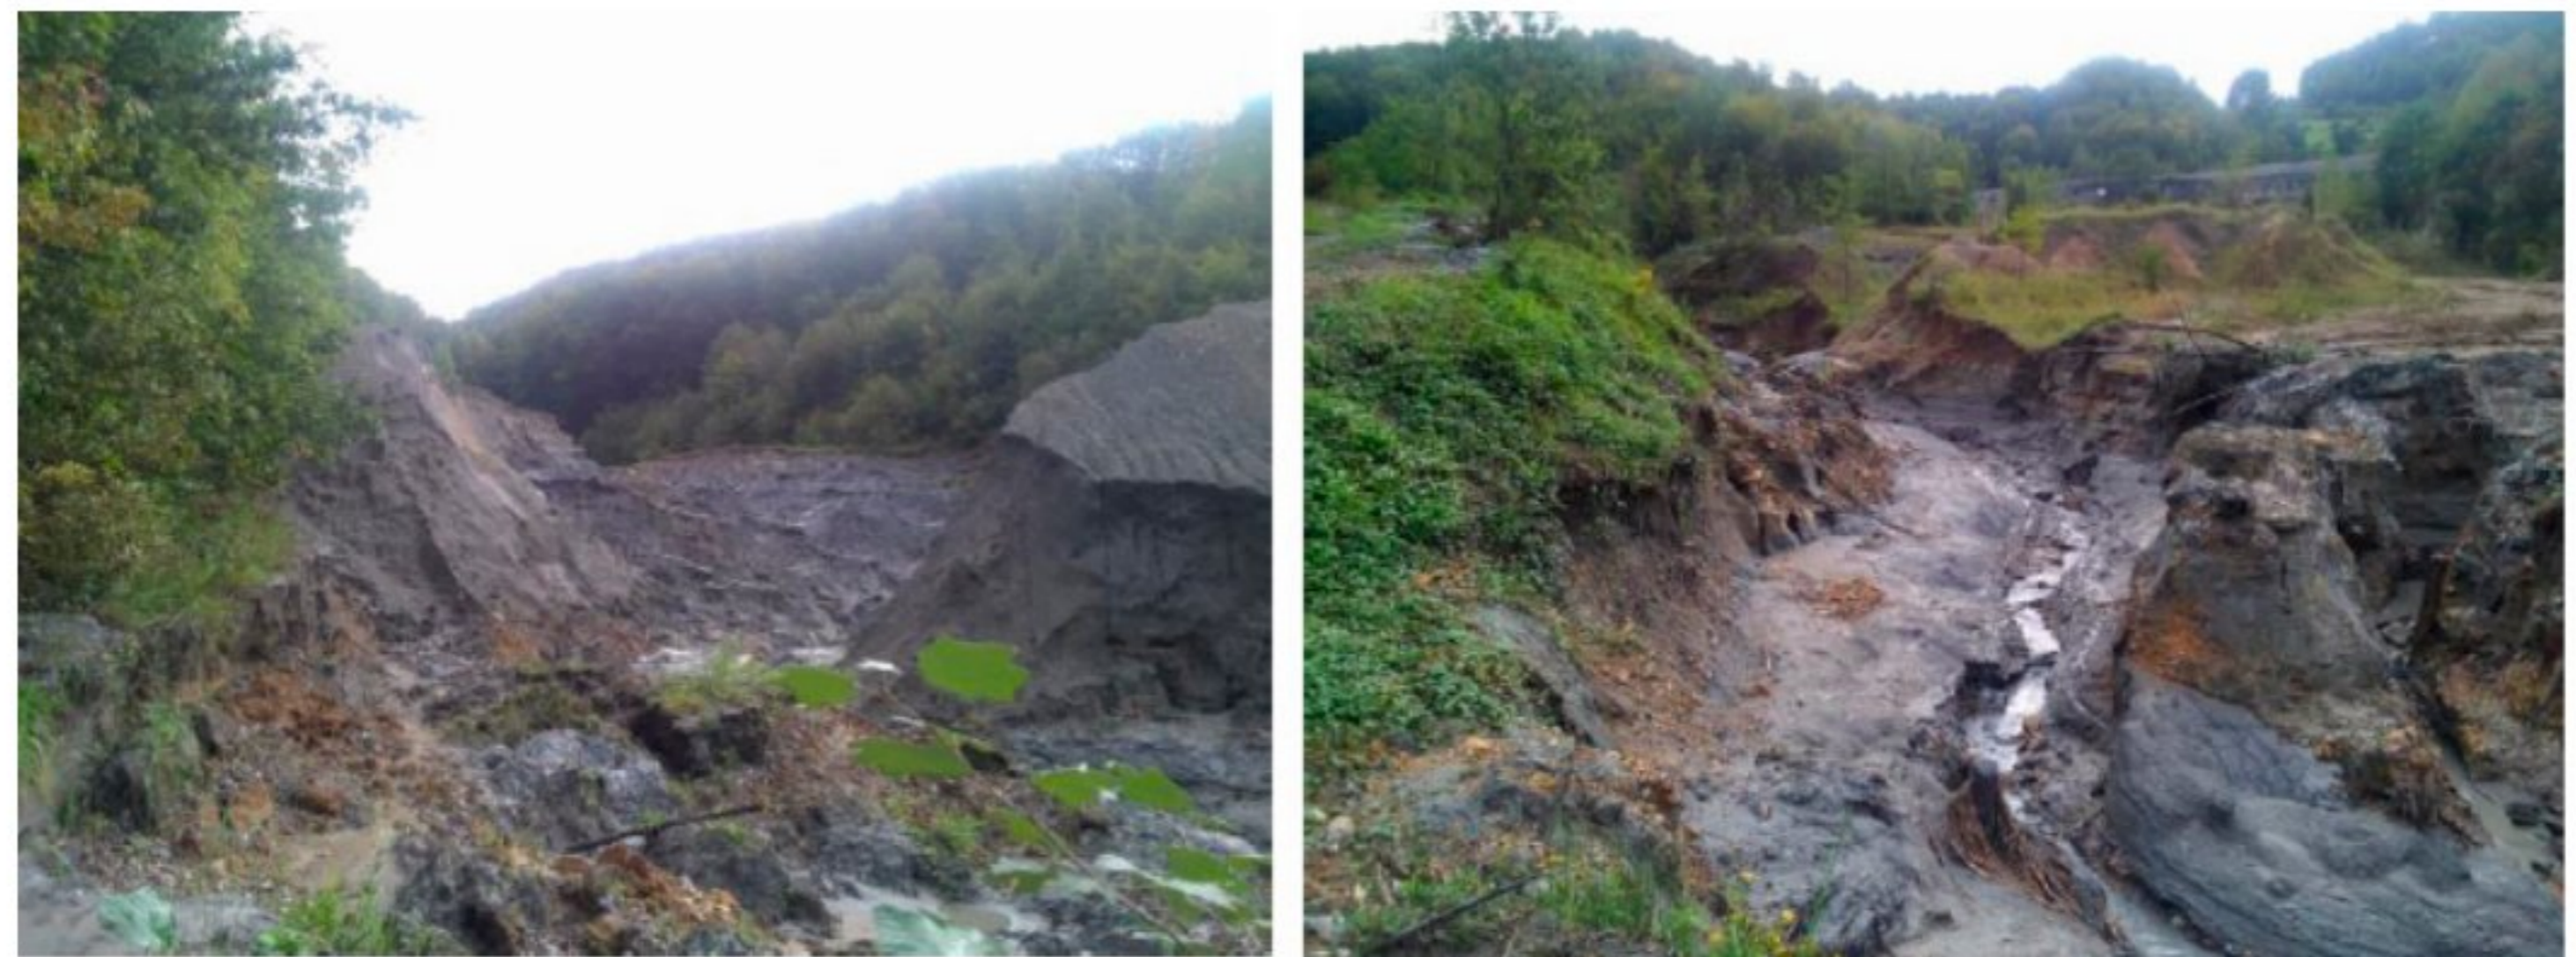
On 13 May 2014, due to the inflow of a large amount of precipitation and the saturation of tailings with water, there was a filtration disturbance in the eastern field embankment, and as the drainage worked poorly, it caused a break in the embankment and there was an overflow of the deposited tailings from the eastern field (Figure 4). On that occasion, a flood wave was formed, and the spilled tailings reached the Kostajnička River, where they were further transported to the Korenita River. Considering that there was intense rainfall for days (from 13 to 16 May), the spilling of eastern field tailings was recorded for days. Until that moment, the western field was stable, without visible water on the surface.

Figure 4. The damaged embankment of the eastern field. Reproduced with permission from the Water Institute “Jaroslav Černí” [10].

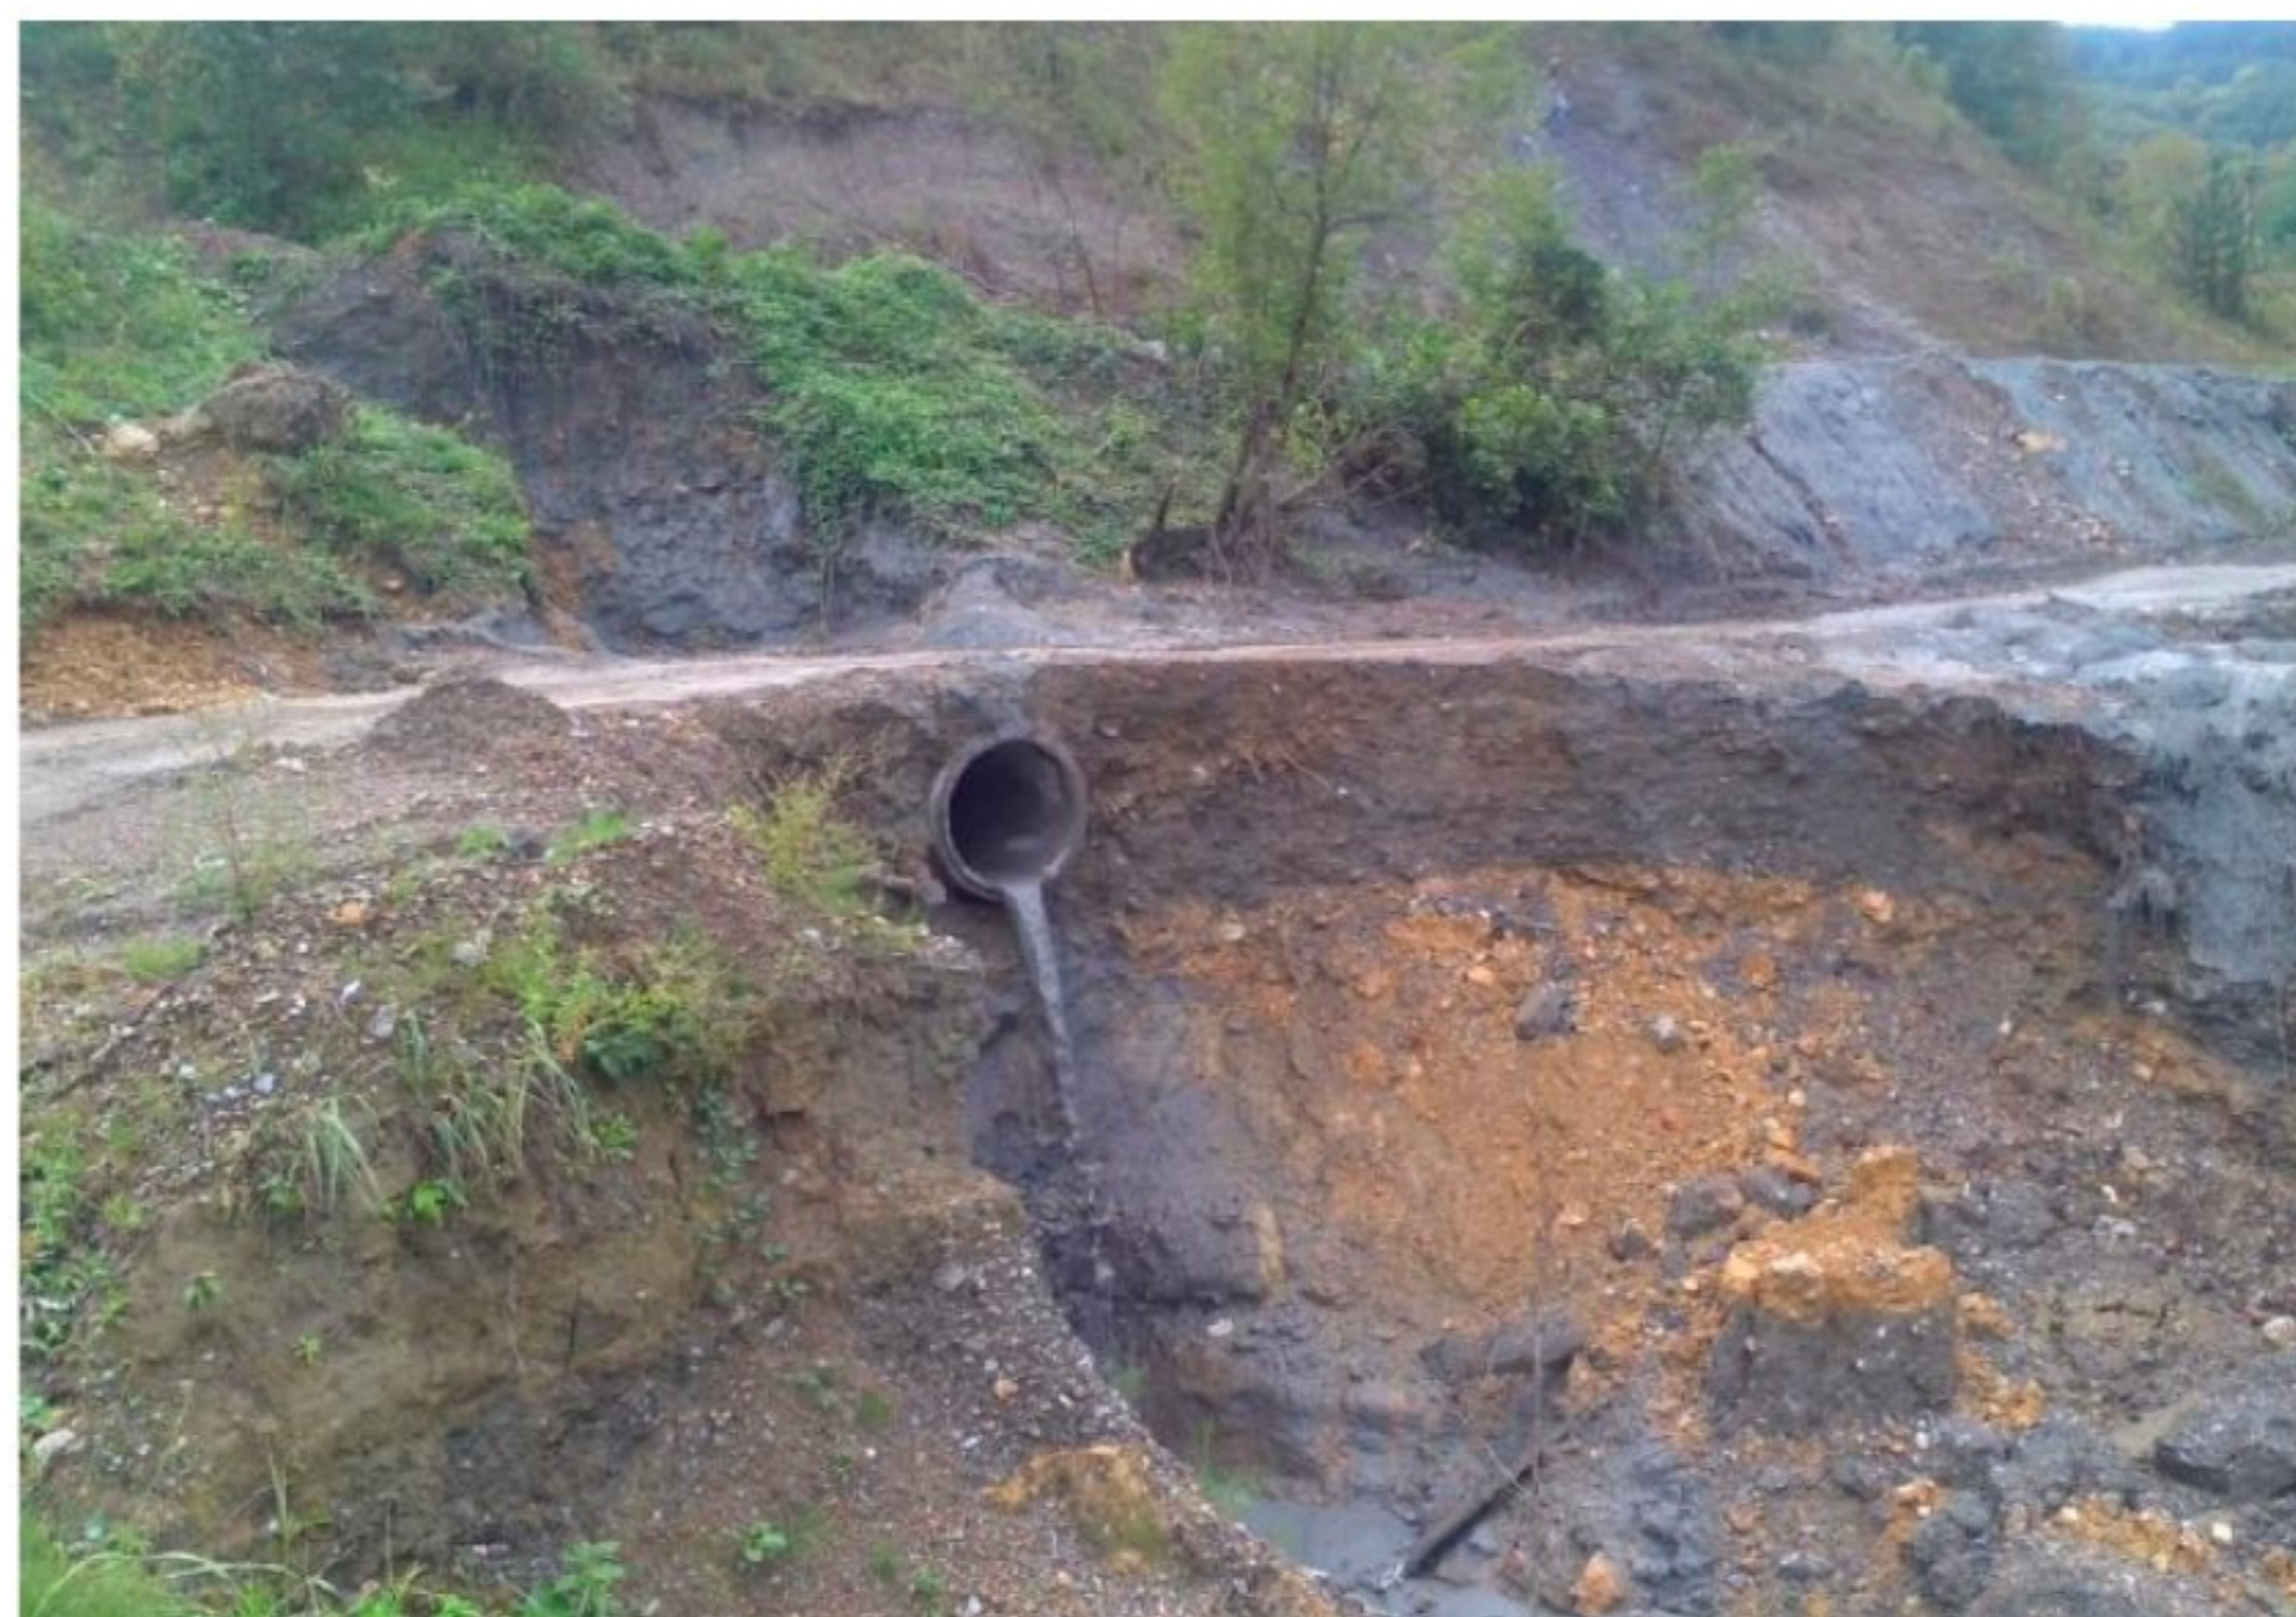
Just two days later, on 15 May 2014, continuous rainfall triggered a natural landslide above the western field. The landslide was particularly concerning because it added a large amount of debris into the western field, which was already at risk due to the heavy precipitation. The additional weight from the landslide further stressed the embankment, weakening its integrity. On that occasion, the pipe culvert regulating the Bezimeni Stream on the western flank of the TSF was damaged (Figure 5).

Figure 5. The damaged pipe culvert on the western field. Reproduced with permission from the Water Institute “Jaroslav Černí” [10].

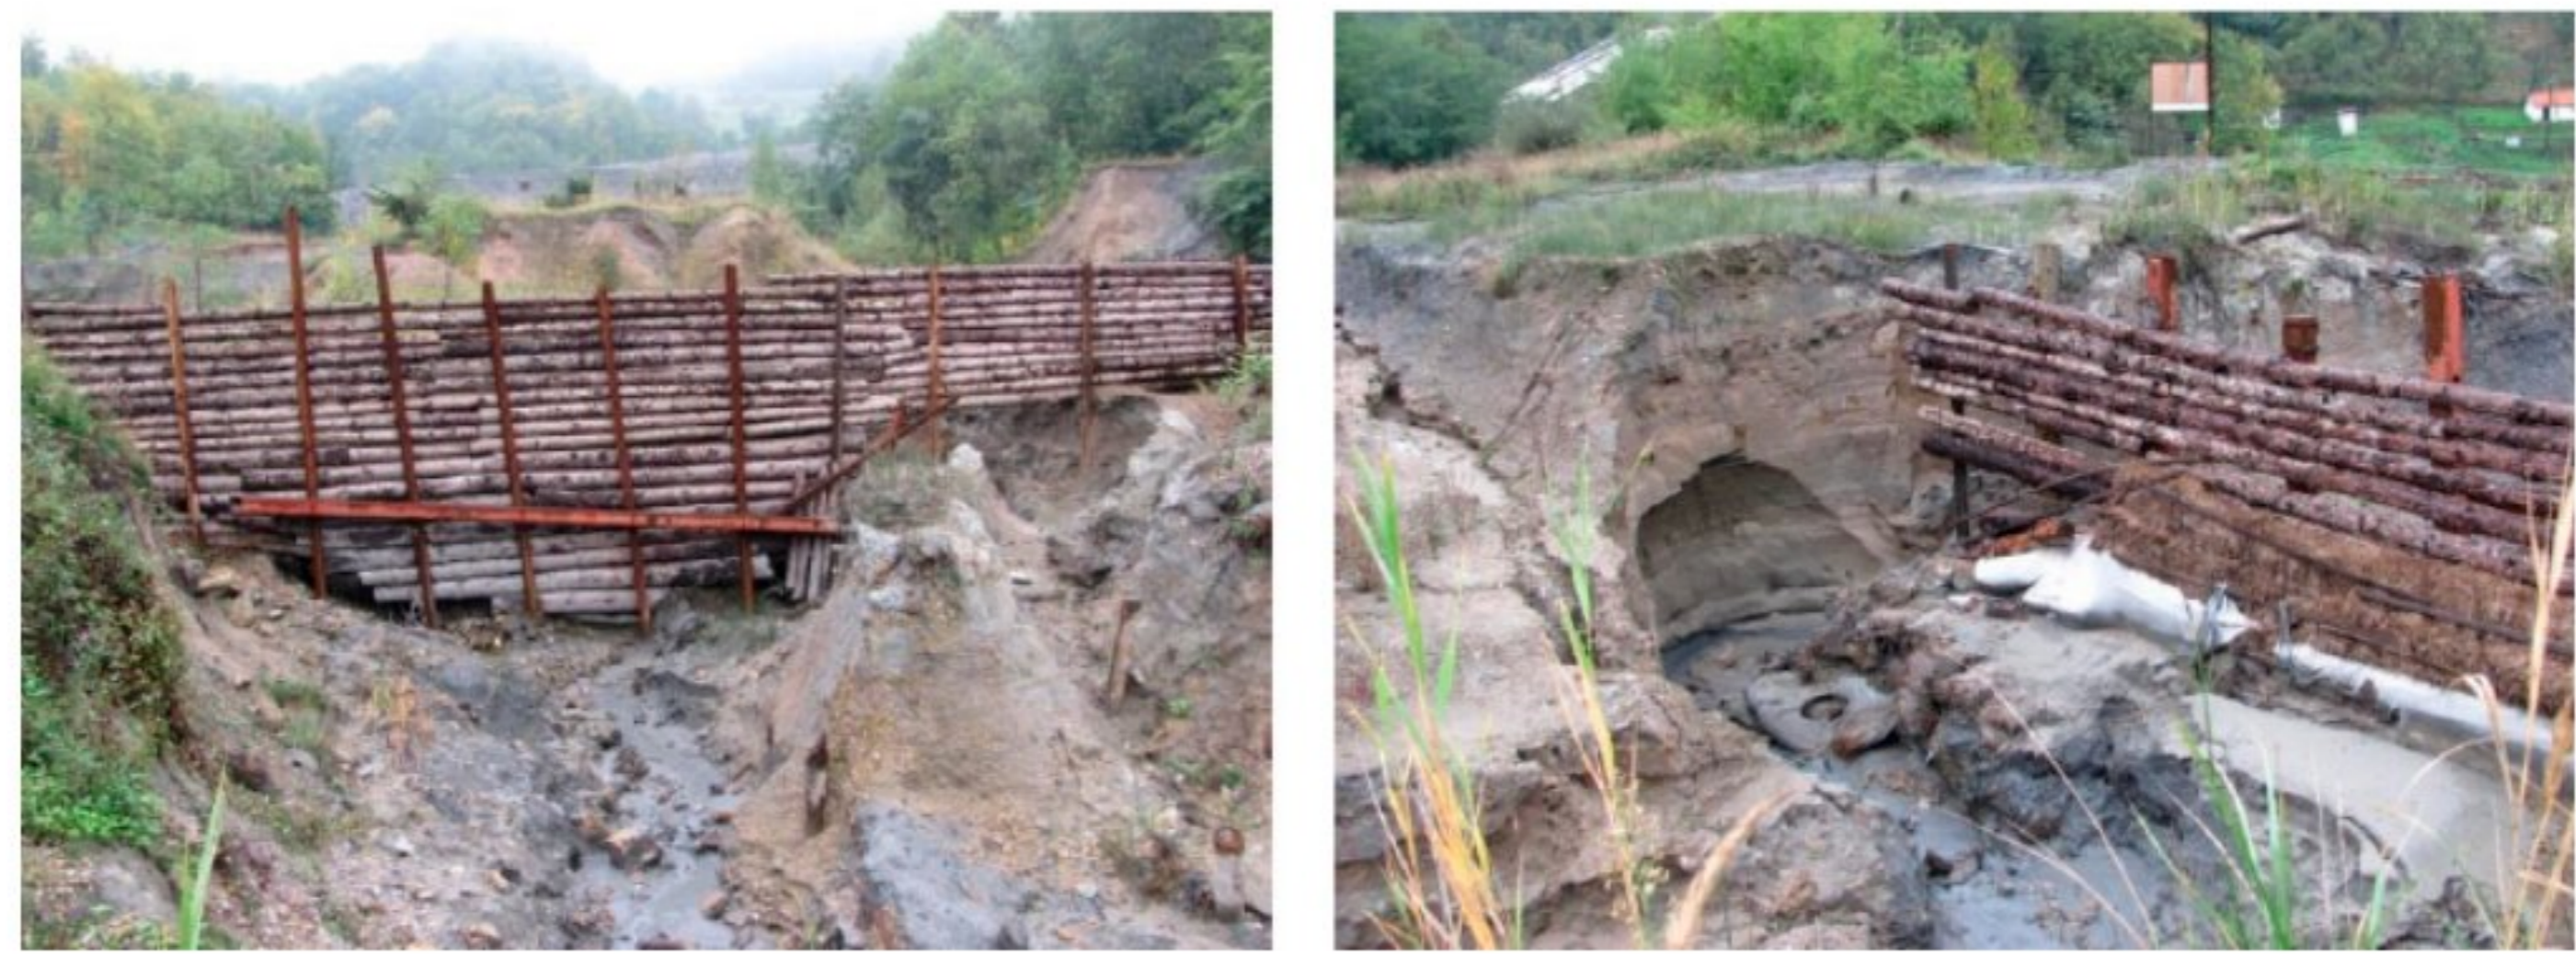
On 23 May 2014, the Bezimeni stream began to fill the western field with water, which finally caused the western field embankment to breach [5]. An even larger volume of tailings into the surrounding environment was released than in previous phases. The release of tailings lasted for days after those temporary measures for the reconstruction of the TSF were introduced. The improvised wooden embankment was installed (Figure 6).

Figure 6. The improvised wooden embankment of the eastern field. Reproduced with permission from the Water Institute “Jaroslav Černi” [10].

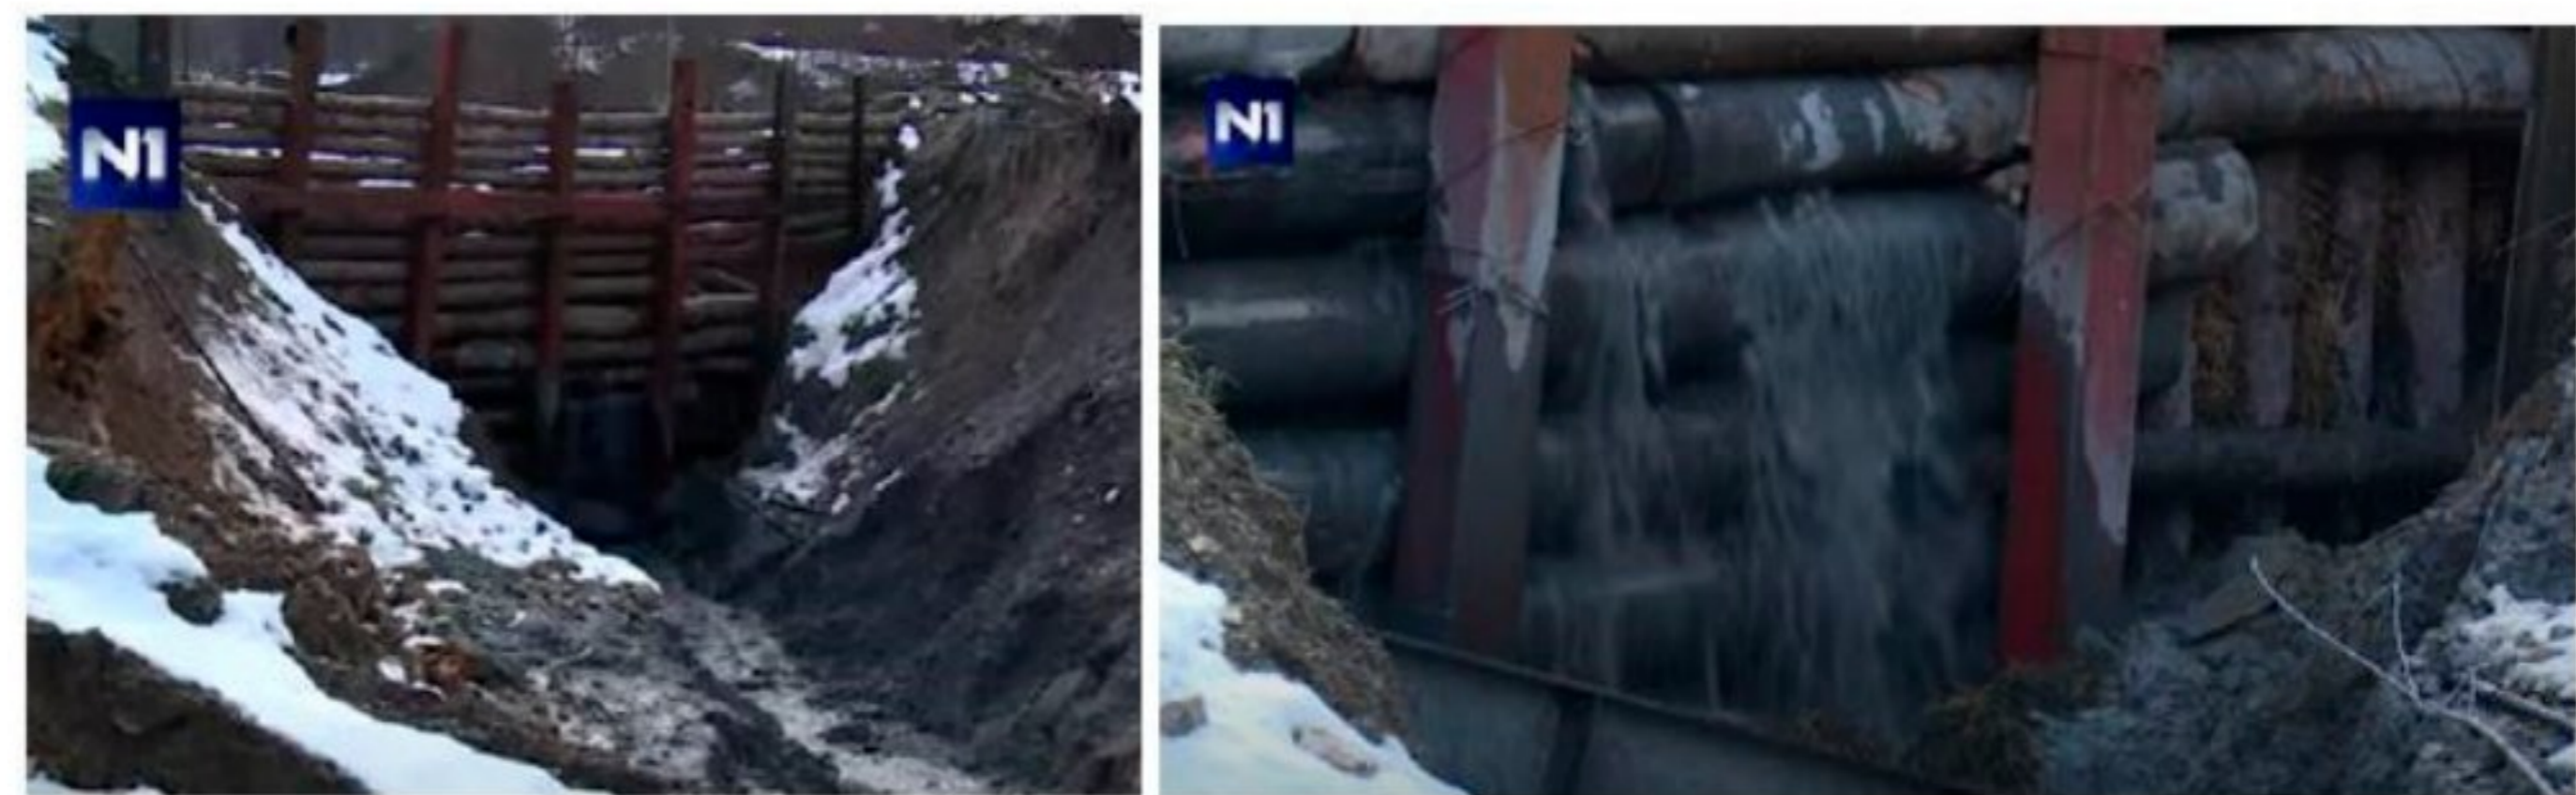
On 17 July of the same year, the tailings spilled again when the already-damaged eastern field embankment, which was temporarily blocked off by the wooden embankment at that moment, was breached and additional tailings spilled into the Kostajnička River (Figure 7) [18]. The repeated failure highlighted the need for more robust remediation efforts and long-term solutions to prevent future accidents of this nature.

Figure 7. The temporarily blocked eastern tailings field was breached again on 17 July 2014. Reproduced with permission from N1 Television [19].

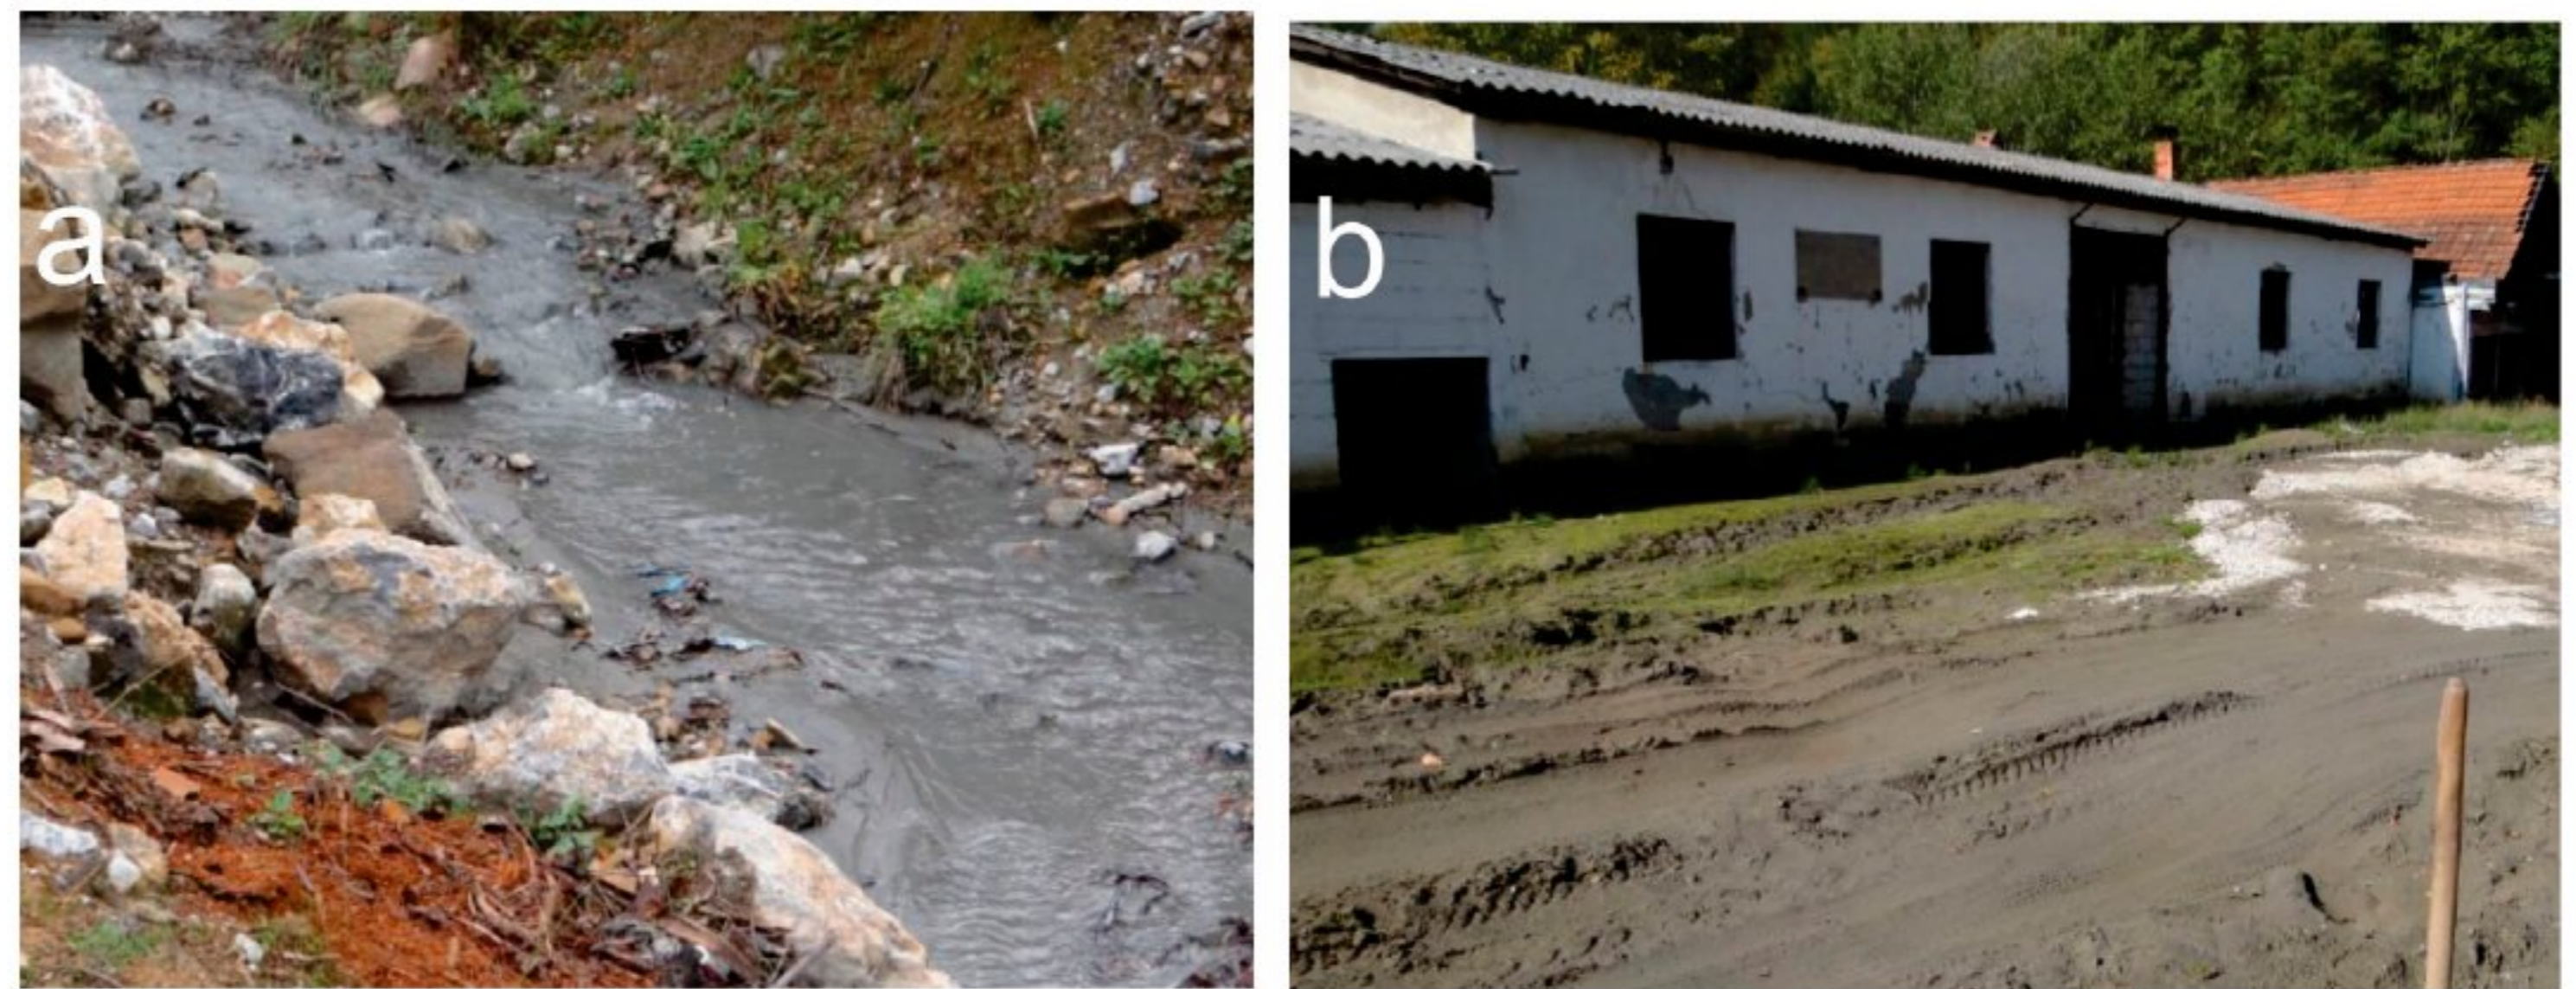
During the accident, a total of between 70,000 and 100,000 m³ of the deposited tailings spilled from the TSF, with most of the tailings spilling from the eastern field [20]. The beds of the Kostajnička River and the Korenita River were devastated, especially the unregulated parts of the riverbeds. The spilled tailings were deposited on the banks of the Kostajnička River, spanning 5 km, and the Korenita River, spanning 20 km, up to the confluence with the Jadar River [11]. Downstream from the TSF, deposits of spilled tailings were created, which were 5–10 cm thick and 50–75 m wide (Figure 8a,b) [21]. It has been estimated that the total contaminated surface of the arable and non-arable land was around 400 ha. Road No. 149 was completely closed off, and several residential buildings were completely demolished [10]. There were no human casualties [5].

Figure 8. Tailings deposits in the bed of the Kostajnička River (a) and on the surrounding terrain (b). Reproduced with permission from the Water Institute “Jaroslav Černi” [10].

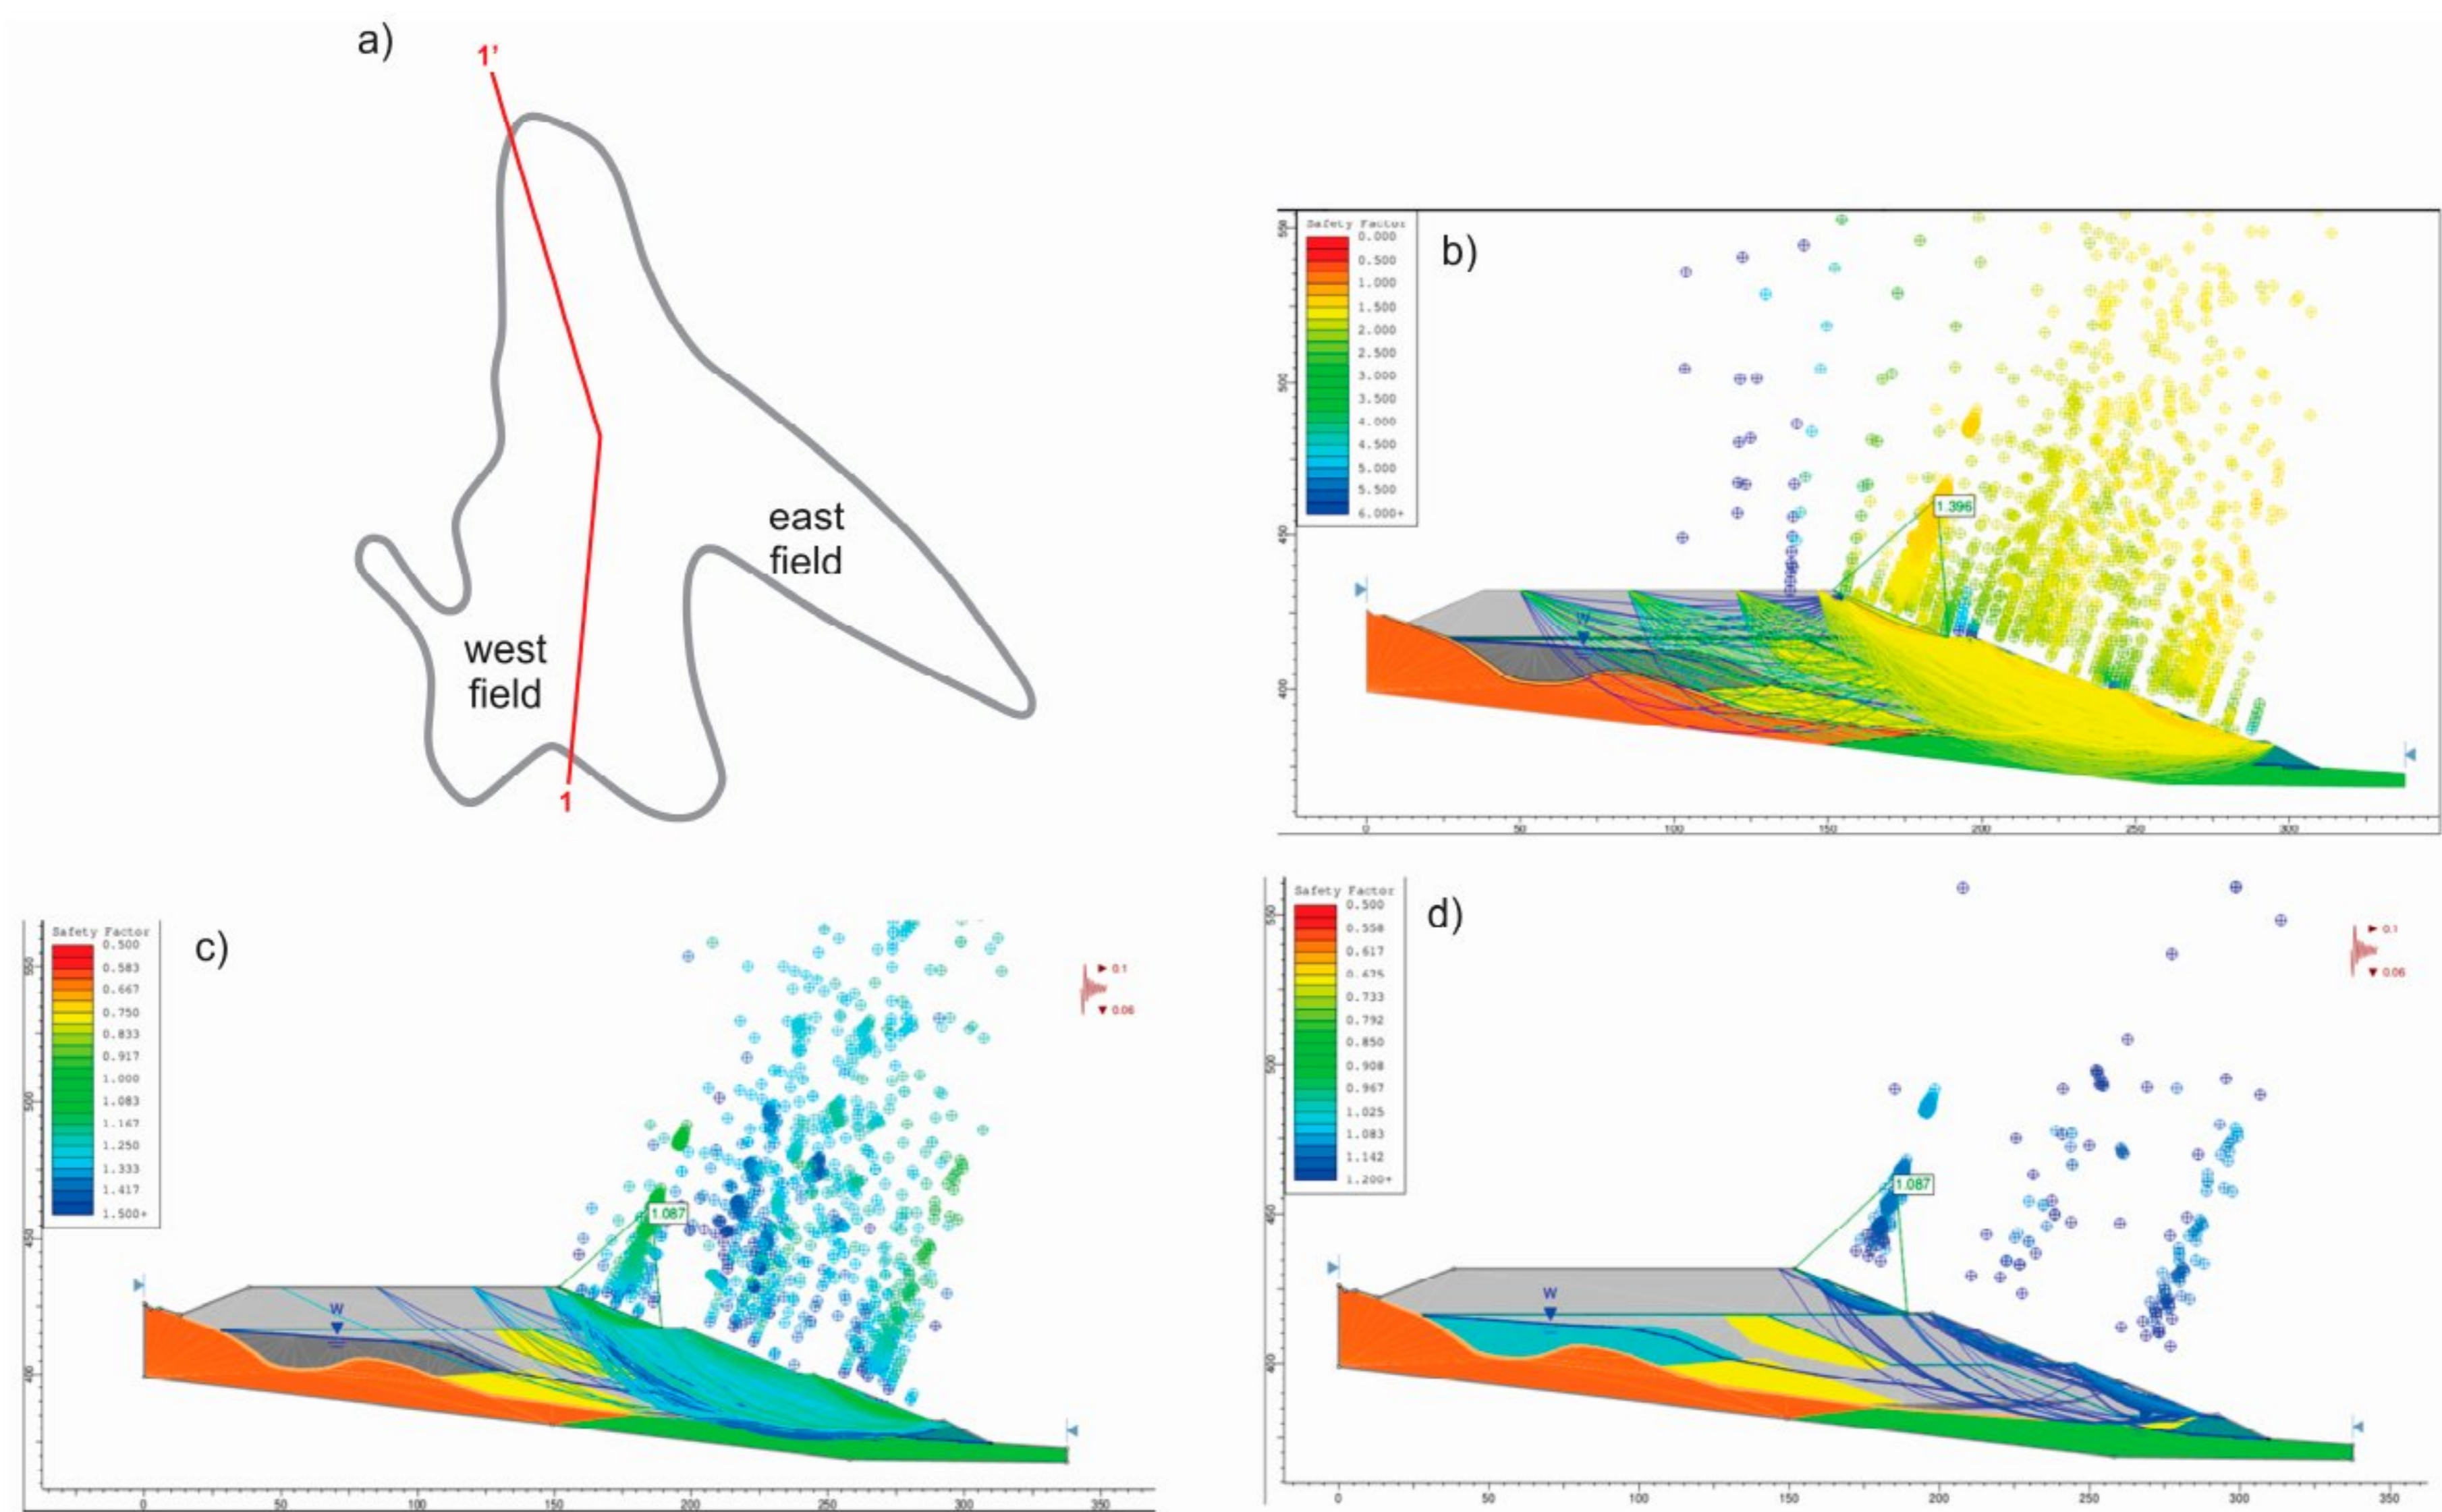
The stability analysis of the reconstructed TSF was conducted for a characteristic longitudinal section, marked as Section 1–1’ in Figure 9a. This section was chosen because in the case of the worst possible scenario, it would give the worst results due to the largest amount of deposited tailings along that section and steep angles of the surrounding terrain [11].

Based on the obtained results of the stability analysis, it can be concluded that the TSF is stable in static and dynamic conditions. These data provide a good basis for risk assessment of another accident at the TSF of the “Stolice” mine. If the 3 × 5 risk assessment matrix is taken into account, the probability of an accident based on the obtained results of the stability analysis can be assessed as “low”. The significance of the consequences is equated with the significance of the already-recorded consequences of accidents from 2014,

Figure 9. Stability analysis of the reconstructed TSF: (a) position of the profile used for analysis; (b) result for static load; (c) result for earthquake load; (d) result for earthquake + liquefaction load. Reproduced with permission from the Water Institute “Jaroslav Černí” [11].

Load Type	Fs [11]	Meaning
Static	1.396 (Figure 9b)	Acceptable Fs. TSF can be considered long-term stable [32].
Earthquake	1.087 (Figure 9c)	Acceptable Fs. TSF can be considered long-term stable [32].
Earthquake + Liquefaction	1.087 (Figure 9d)	Acceptable Fs. TSF can be considered long-term stable [33].
