Damage quantification of built stone on Dark Gate (Belgrade, Serbia): sample of damage index application for decay rate evaluation

Maja Franković, Nevenka Novaković, Vesna Matović

Received: 16 May 2014 / Accepted: 31 October 2014 / Published online: 4 December 2014
© Springer-Verlag Berlin Heidelberg 2014

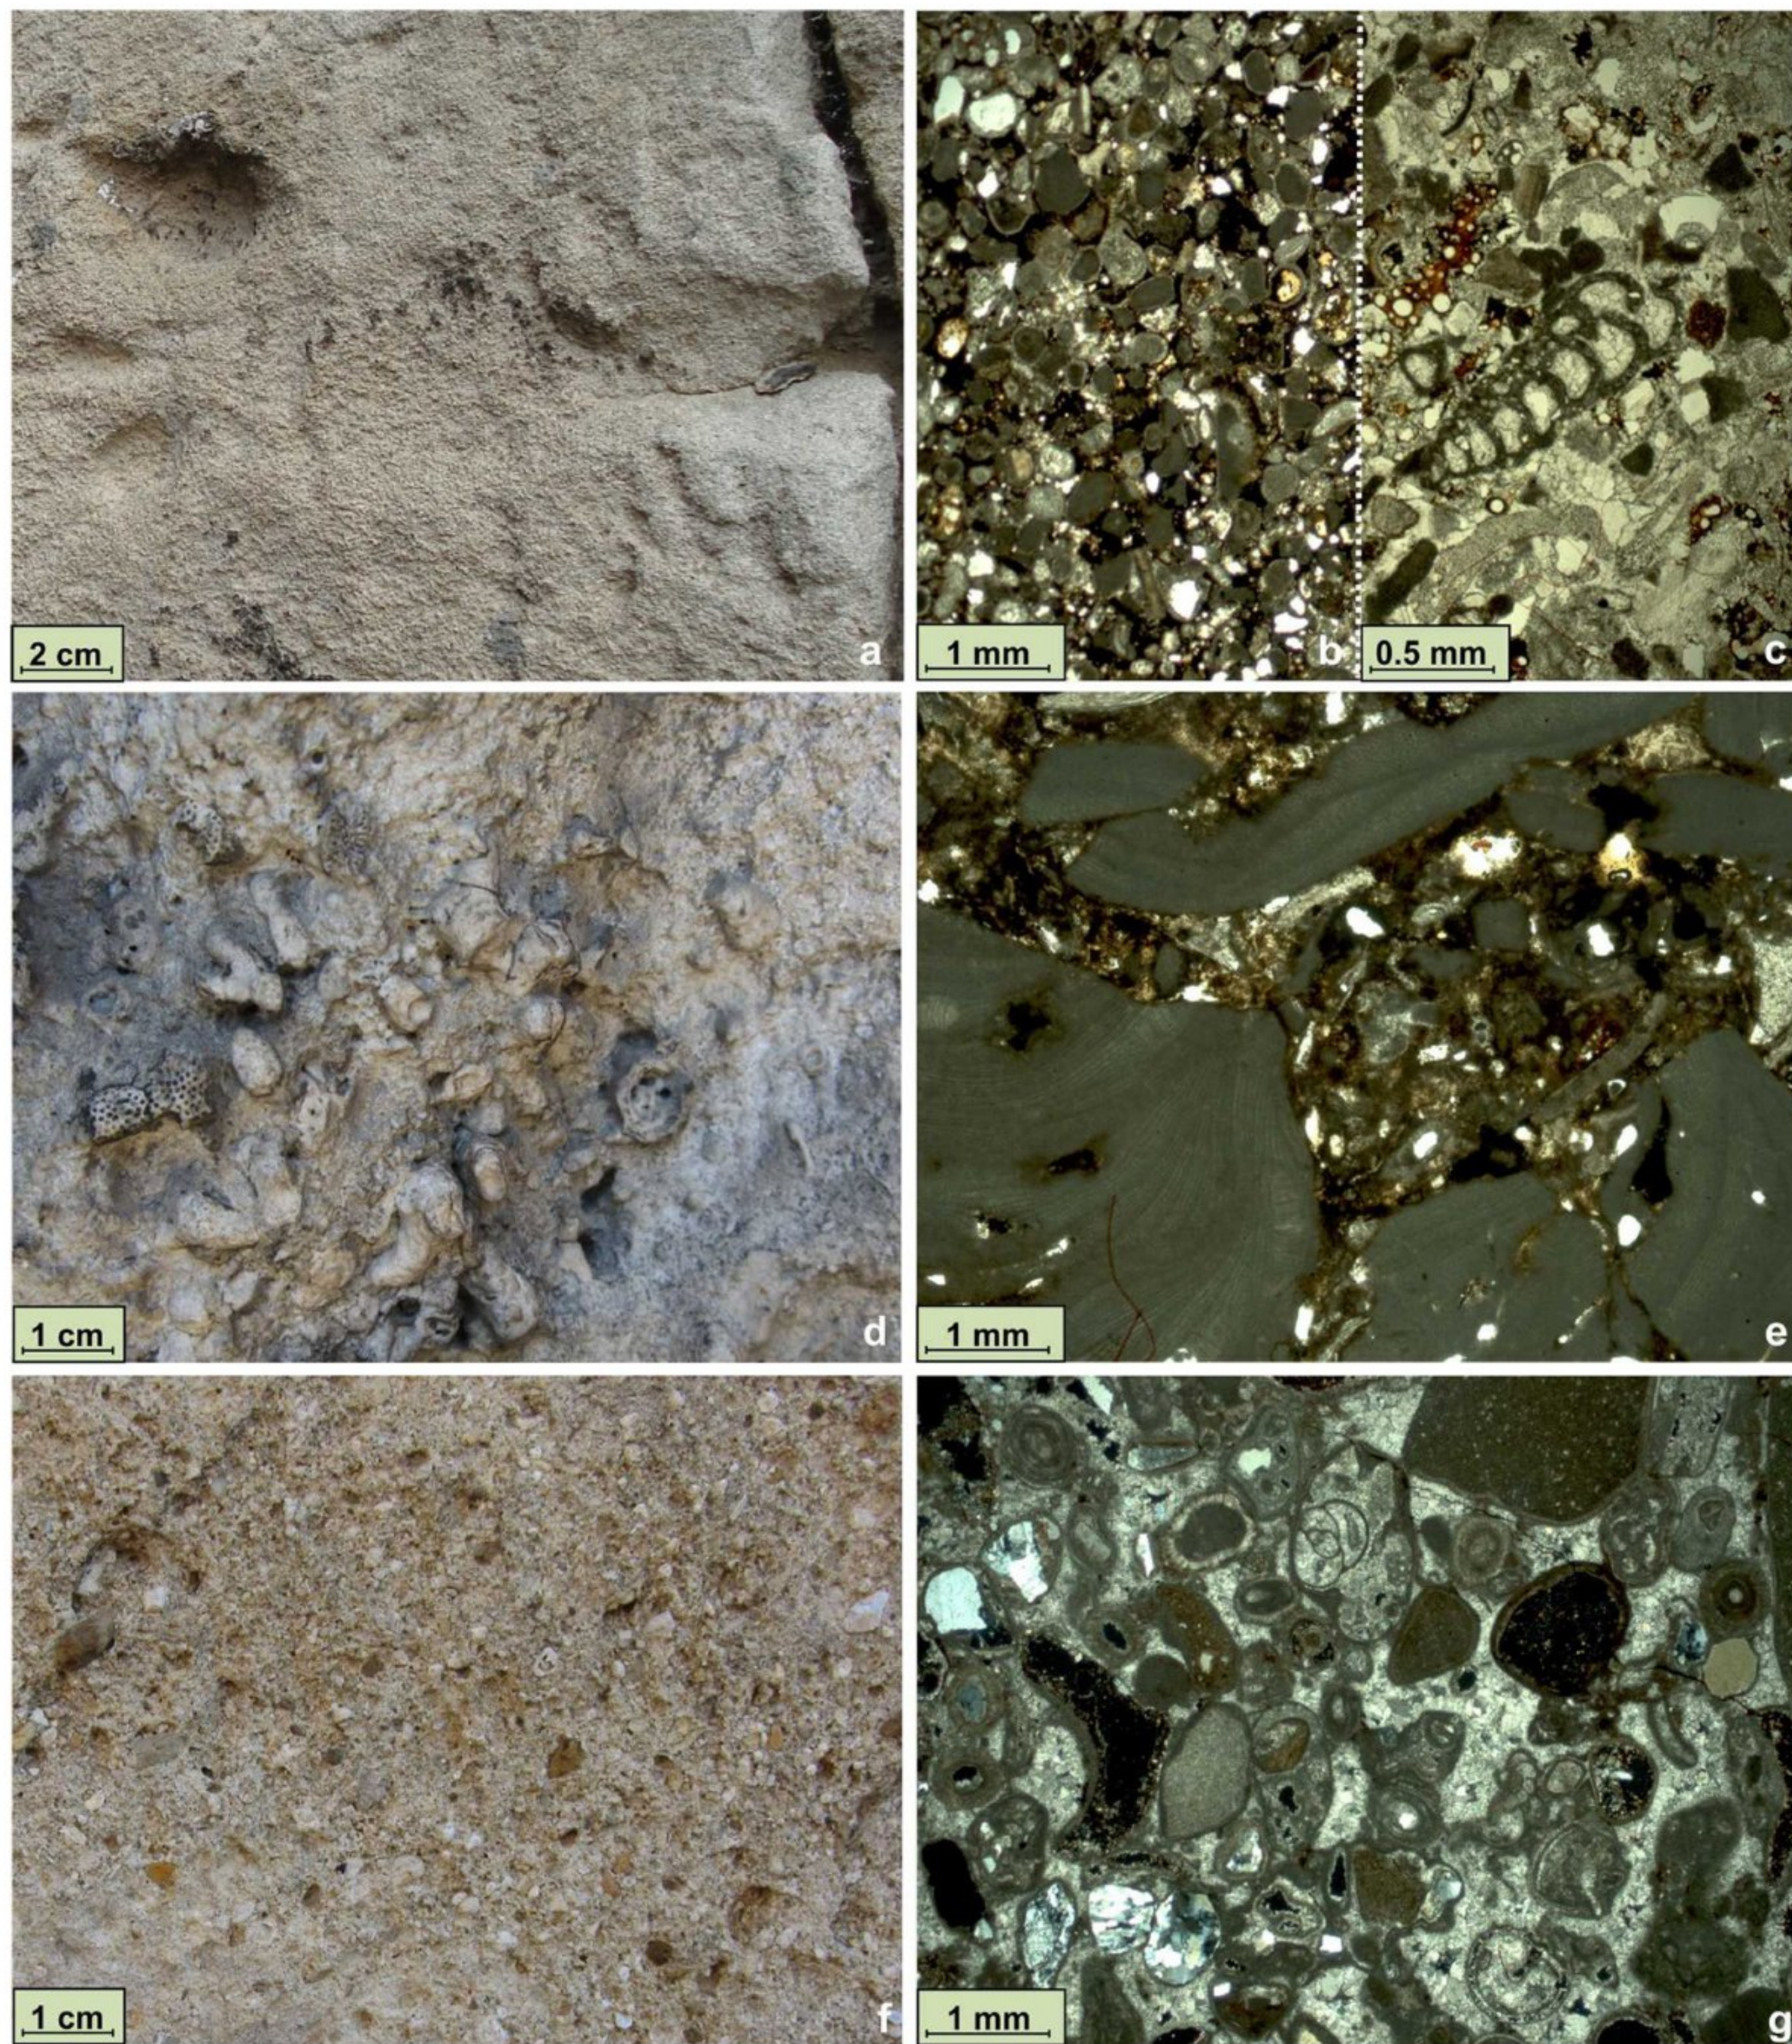
Fig. 2 Images and photomicrographs of stones built in the Dark Gate: (a–c) Grainstone; (d–e) Algal rudstone; (f–g) Rudstone

Grainstone microfacies (biosparite) is the dominant type of built stone. It is light gray in color and massive texture (Fig. 2a). It is predominantly composed of densely arranged fragmented microfauna. Generally, all bioclasts are the uniform size, between 0.2 and 1.5 mm, mostly about 0.5 mm. Densely distributed bioclasts include shallow water, debris of red algae, foraminifera, fragments of mollusks shells and echinoids (Fig. 2b, c). The ooids were also registered in this microfacies. The cores of the ooids are composed of silicic-clastic grains. Ortochem is sparite with interparticle to intraparticle porosity.

Algal rudstone microfacies (algal biomicsparrudite) are white biogenic limestones, poorly cemented with very porous texture, which is characterized by irregular or lenticular voids and channels (Fig. 2d). Macroscopically observed big preserved or fragmented algal allochem, round to nodular or tabular to irregular shape (up to 5 cm in size), provide a rudite character of stone and prefix *algal* in name. These prevailing allochemical compounds are fossil fragments of red algae (*Lithotamnium ramisissimum*; family Corallinaceae) (Fig. 2e). The algal remains are micrite in composition with a well-developed and prominent mesh texture consisting of micron-sized rectangle chambers. Fragments of some other species (diverse association of reef macro- and microfauna) were also recognized and have chambers partially filled with sparry calcite. The algal biomicsparrudite is a poorly consolidated rock with microsparite bounds with large moldic, vuggy, and interparticular porosity.

Last of all built type is Rudstone microfacies represented by coarse-grained rudites regarding their textural features, i.e., the coarseness of the component especially terrigenous component homogeneous distributed throughout the rock (Fig. 2f). Size of these clasts reaches up to 1 cm. Among the sparry varieties of this microfacies, intrasparrudite, biosparrudite to intrabiosparrudite may be distinguished. They are made of simple and complex intraclasts and fossil fragments of shallow-water organisms, ooids with orthochem of sparry calcite (Fig. 2g). The intraclasts are the coarsest allochem (up to 4 mm in size) and correspond to biomicrite, or micrite, regarding their
