Review of the Failure at the Flotation Tailings Storage Facility of the “Stolice” Mine (Serbia)

Dragana Nišić *

Abstract: A detailed analysis of the accident that occurred at the flotation tailings storage facility (TSF) at the inactive mine “Stolice” in 2014 is provided in this paper. All factors that caused the accident have been analyzed, with a review of the consequences of the accident, their accident class according to the Global Industry Standard on Tailings (GISTM), and the implemented measures to rehabilitate the TSF and the surrounding area after the accident. It has been concluded that the TSF had not been properly maintained even before the accident occurred and that the unfavorable weather conditions in Serbia in the May of that year contributed to the filtration disturbance and multiple tailings spillages from the TSF. It has been stated that the consequences according to the GISTM span from “low” to “significant”, with the group of environmental consequences having the highest rank (3). Although the accident occurred without recorded human casualties, with the damage being of a local nature, it is considered one of the most significant accidents at a TSF in Serbia

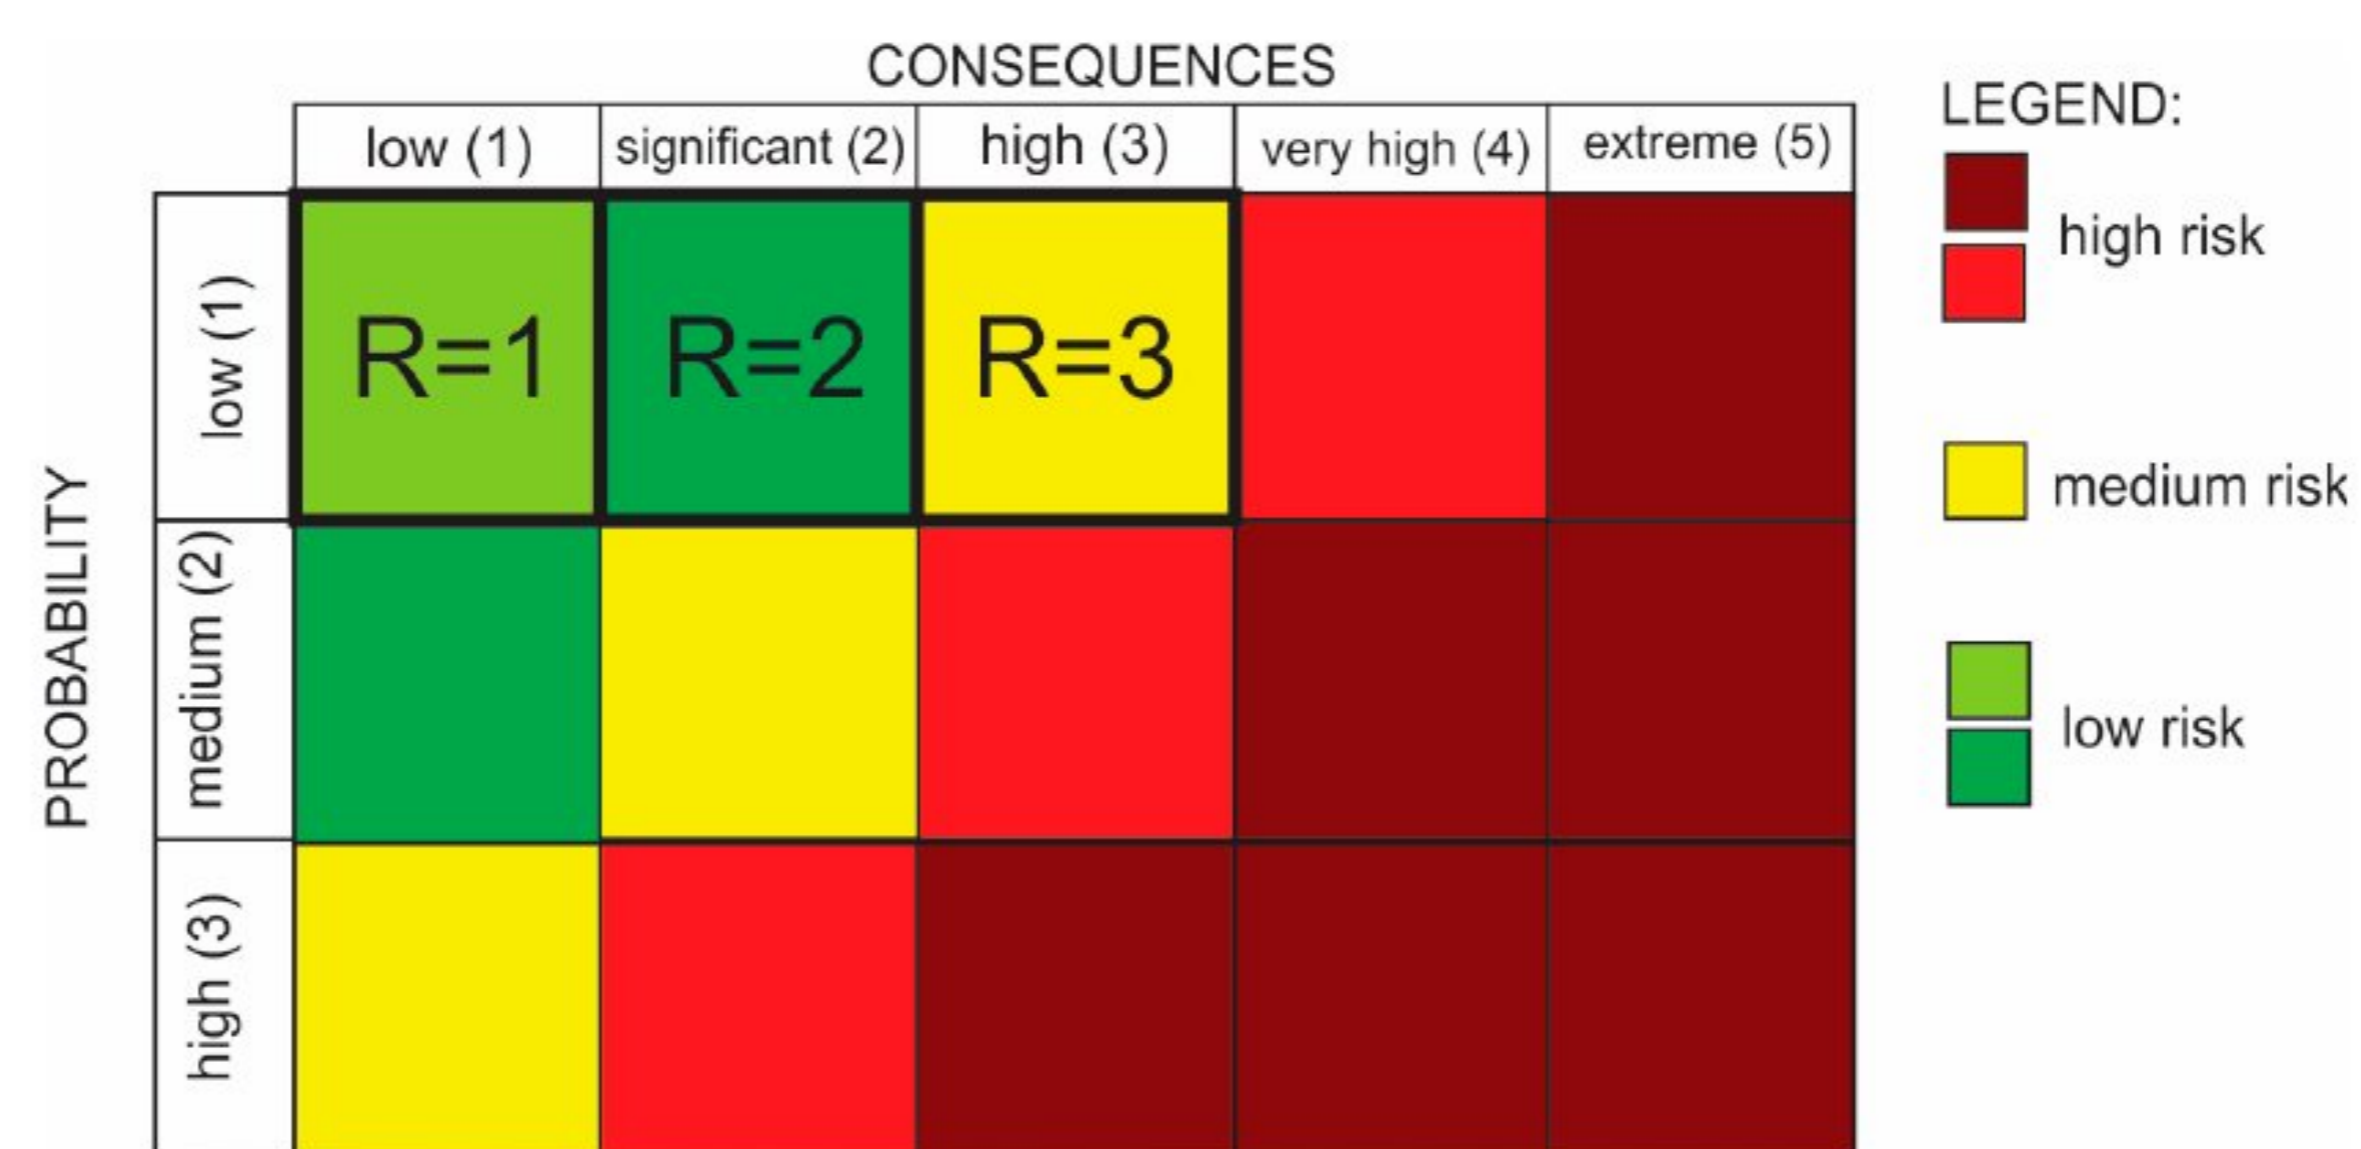
Figure 10. Risk matrix 3 × 5.

when they were assessed as consequences of “low to high” significance. Based on these two parameters, a “low-to-medium” risk level, ranked between 1 and 3, is obtained, which is interpreted as an acceptable risk [34] (Figure 10).
